**Konu** : Konteynerlerin Denize Düşerek Zayi Olması  
Olayına İlişkin Kaza İnceleme Raporu

**CODG(21)01**

Members are informed that ICS has been recommended to actively communicate the lessons from the combined investigation report on the MSC ZOE container loss incident, issued by the Panama Maritime Authority, Dutch Safety Board and Federal Bureau of Maritime Casualty Investigation of Germany.

In the late evening of January 1, 2019 and the early morning of January 2, the containership MSC ZOE lost a total of 342 containers whilst sailing on the North Sea, in the Traffic Separation Scheme (TSS) Terschelling - German Bight. The Panamanian flagged ship was en route from Sines, Portugal to Bremerhaven, Germany. At the time of the accident the ship was sailing in conditions with north-northwesterly winds of 8 Bft and waves coming from abeam on port side. The ship was rolling constantly. The crew first detected that cargo had been lost north of the Dutch Wadden Island Schiermonnikoog, at around 01.00 hours local time<sup>1</sup> (LT) on January 2. North of the island Borkum, around 01.30 hours, the loss of containers overboard was witnessed by the crew. The MSC ZOE changed course to

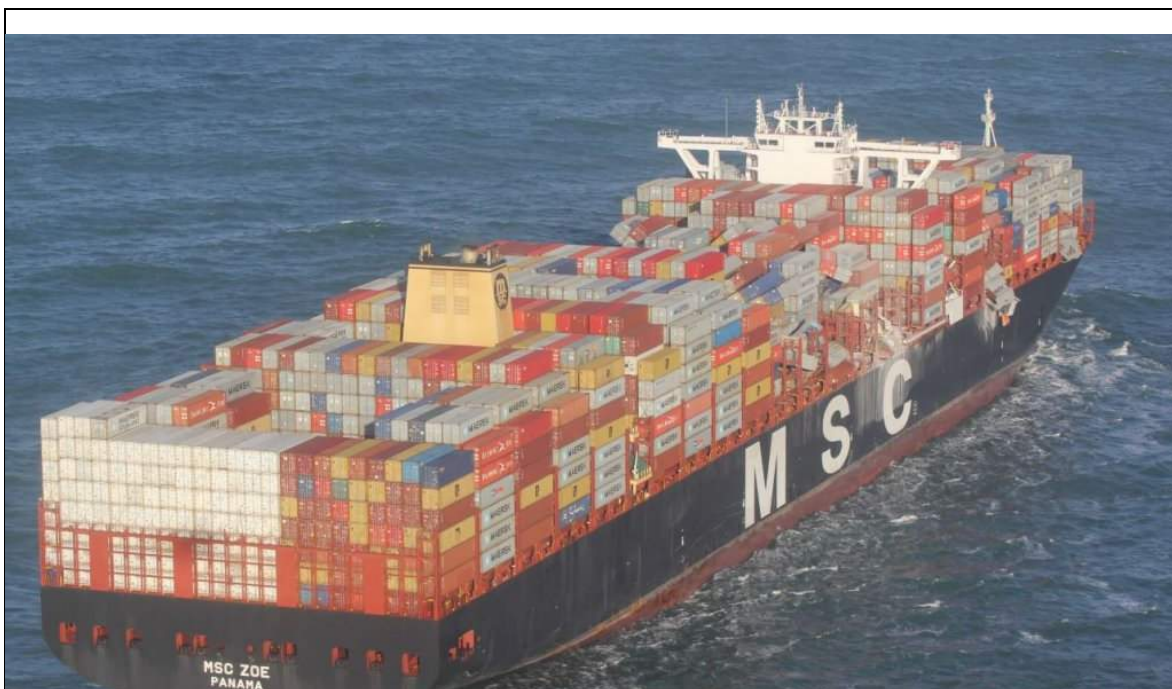
Figure 2: Side view MSC ZOE. (Source: Netherlands Coastguard)

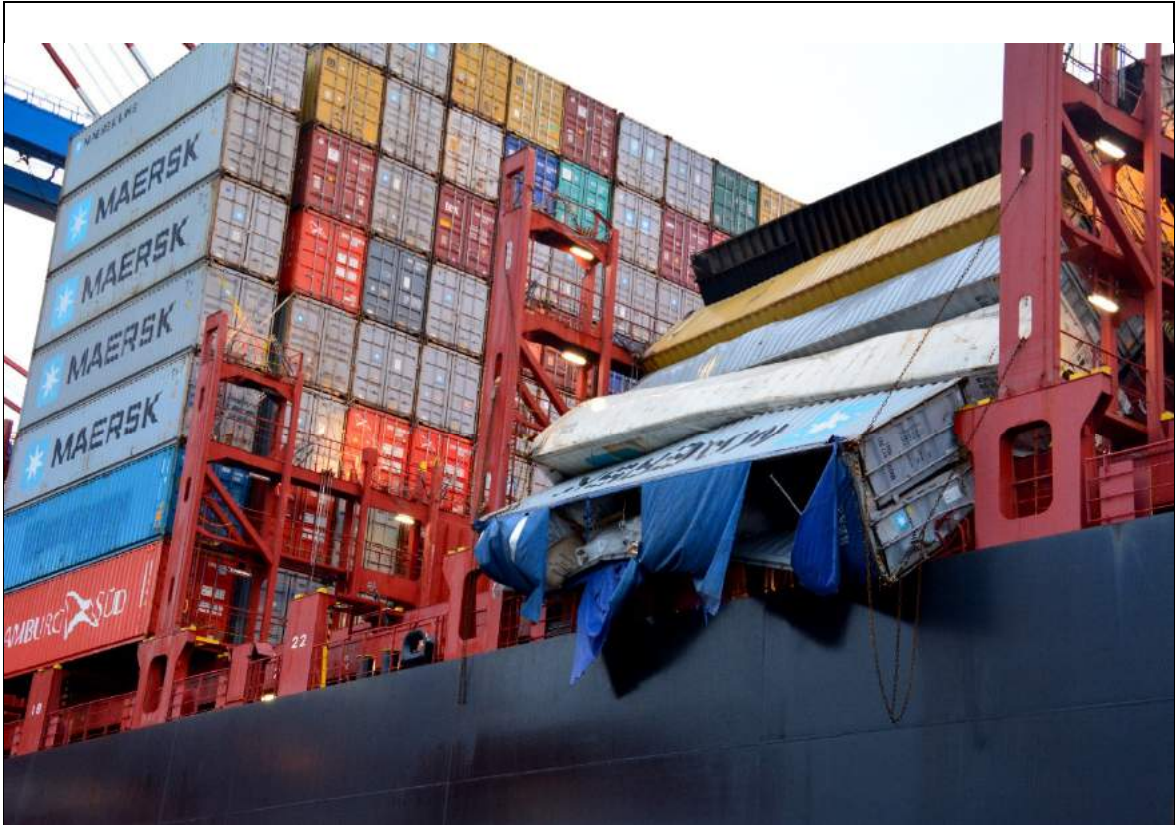
Figure 5: Container with bags with polystyrene balls hanging over the side. (Source: DSB)

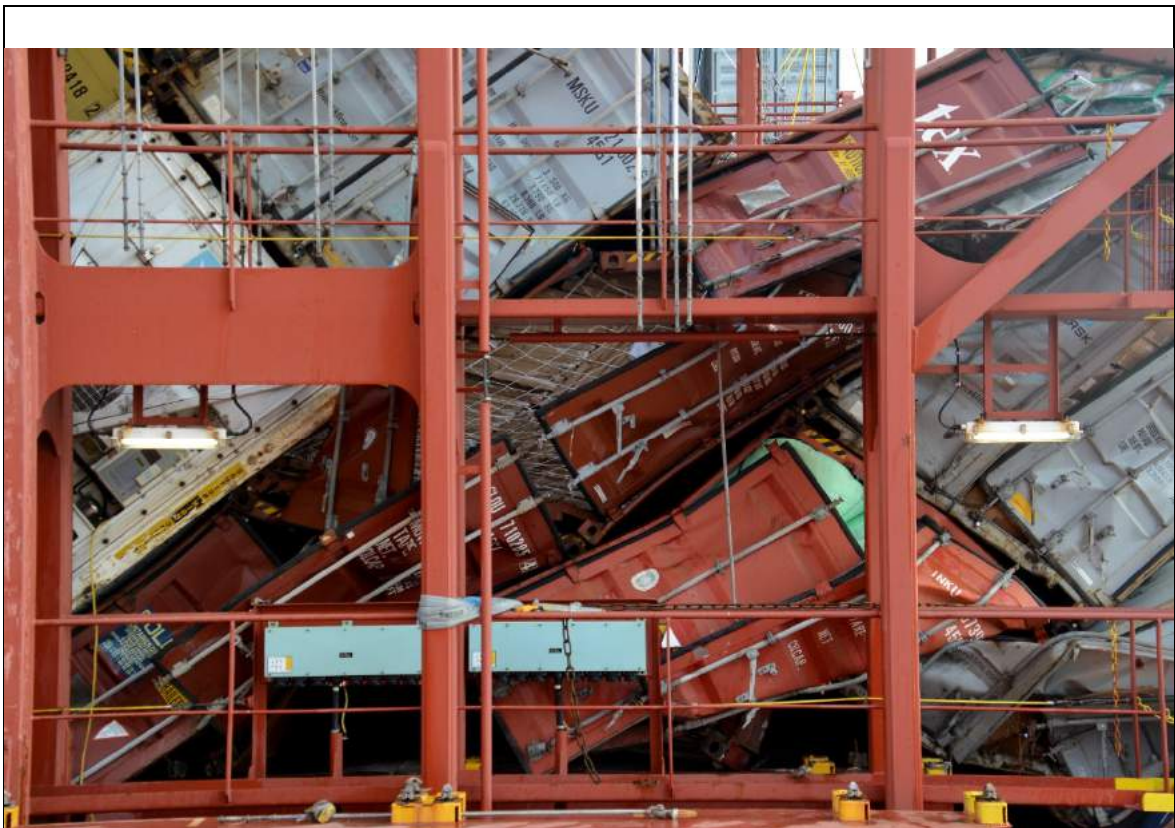
Figure 6: Crushed containers on board MSC ZOE. (Source: DSB)

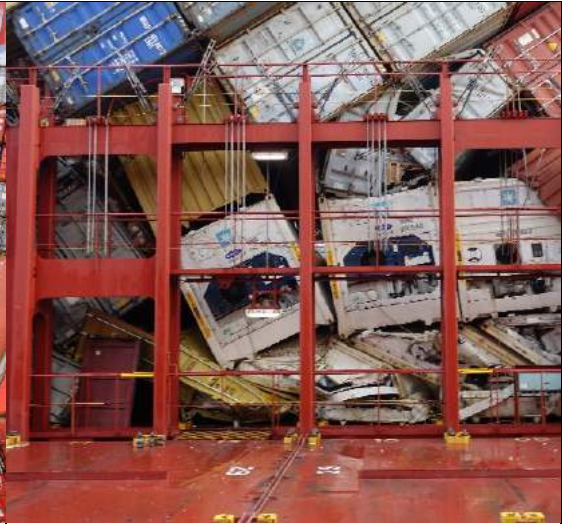
Figure 8: Collapsed containers in bay 26. (Source: BSU)

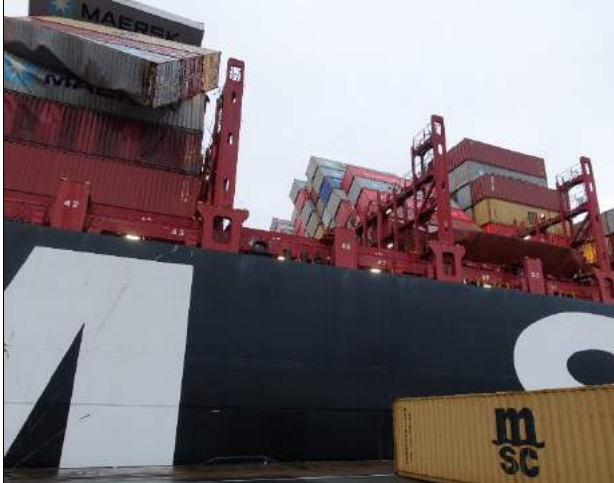
Figure 9: Collapsed rows in bay 42 and 50. (Source: BSU)

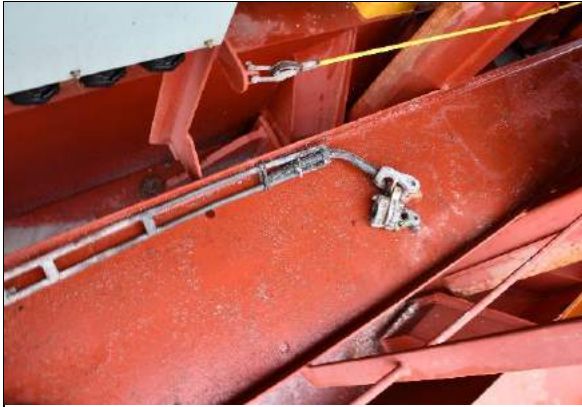
Figure 13: Bent turnbuckle (Source: German Waterway Police)

Figures 13 to 18 show evidences of the damages to lashing material and deck fittings. Some container stacks remained, even on their side, securely fastened to each other with twistlocks. In the bays with damaged or lost containers, broken twistlocks were found. Also bent or deformed lashing rods and turnbuckles were found, as well as broken mounts from the lashing bridges with the turnbuckle still attached.

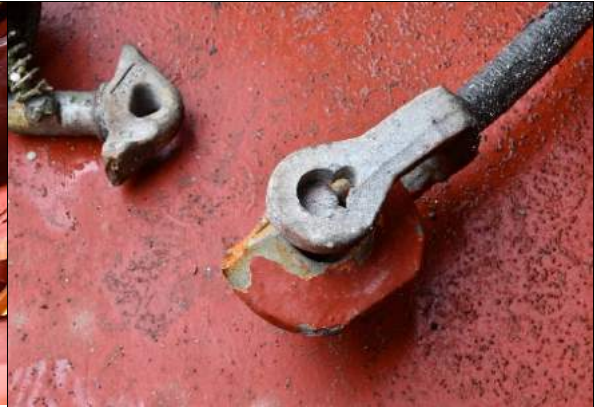
Figure 14: Broken mount from lashing bridge (Source: German Waterway Police)

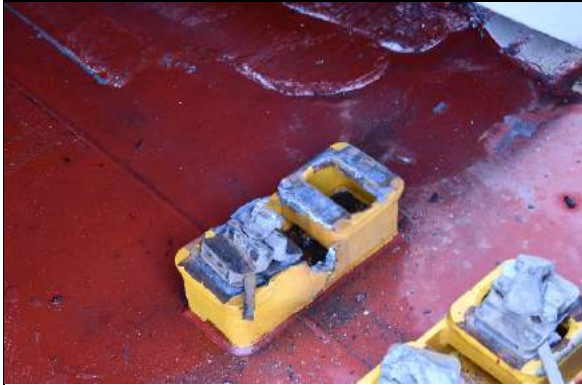
Figure 15: Broken twistlock in a bent deck fitting (Source: German Waterway Police)

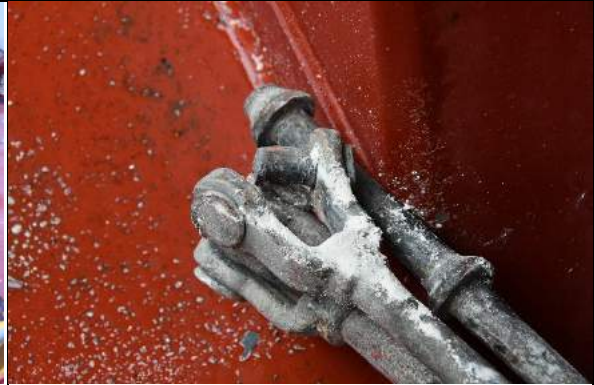
Figure 16: Broken turnbuckle (Source: German Waterway Police)

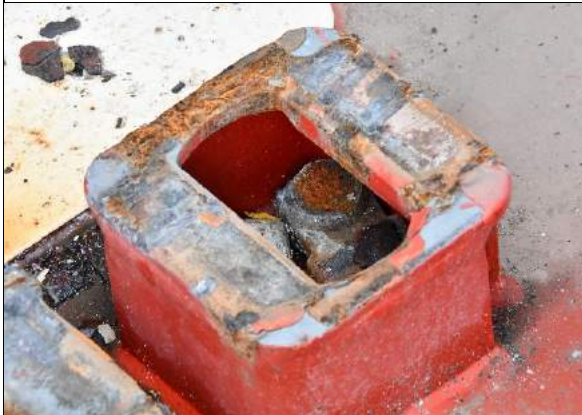
Figure 17: Broken twistlock in deck fitting (Source: German Waterway Police)

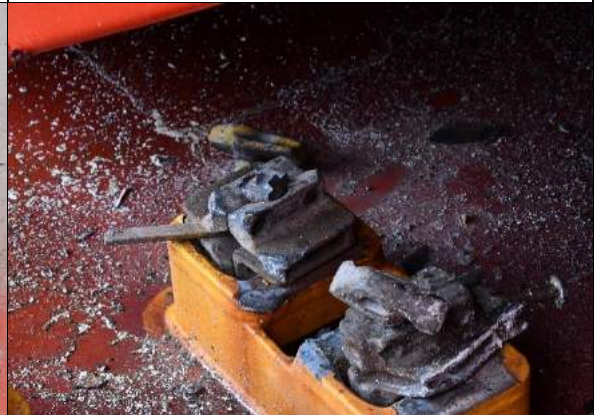
Figure 18: Broken twistlock (Source: German Waterway Police)

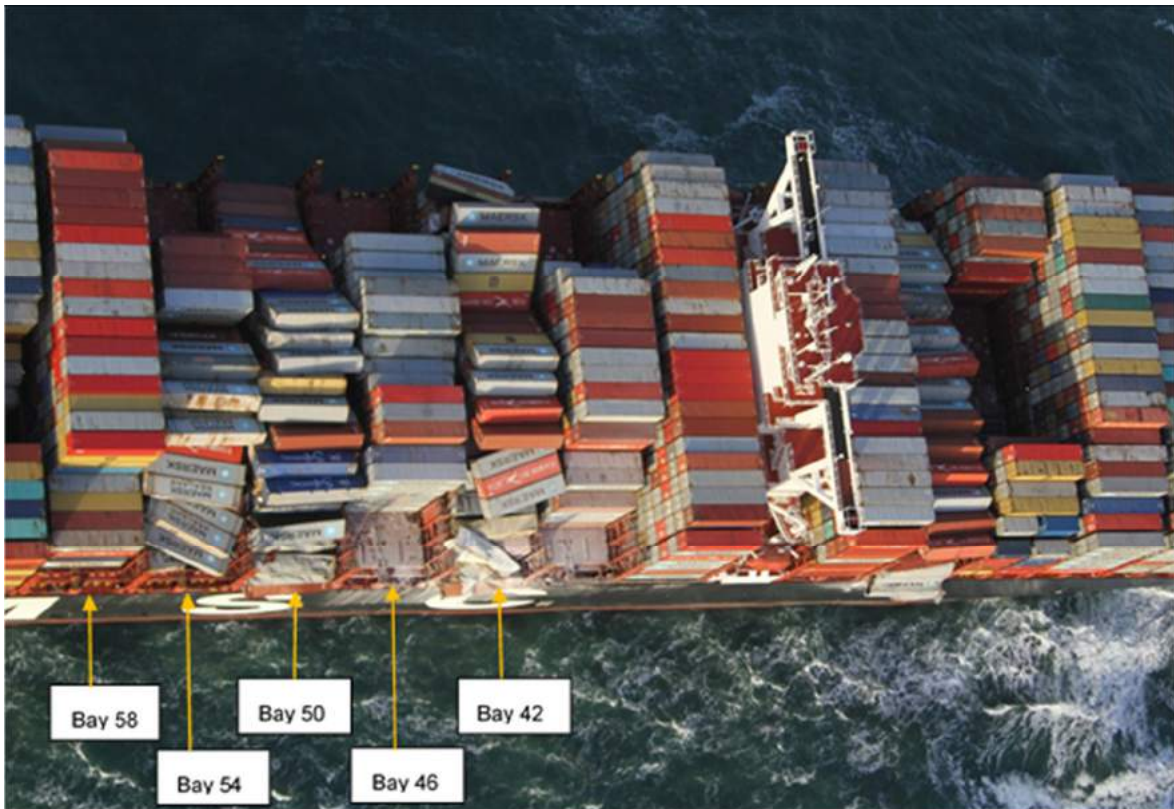
Figure 25: Top view of the bays with lost containers. (Source: The Netherlands Coast guard)

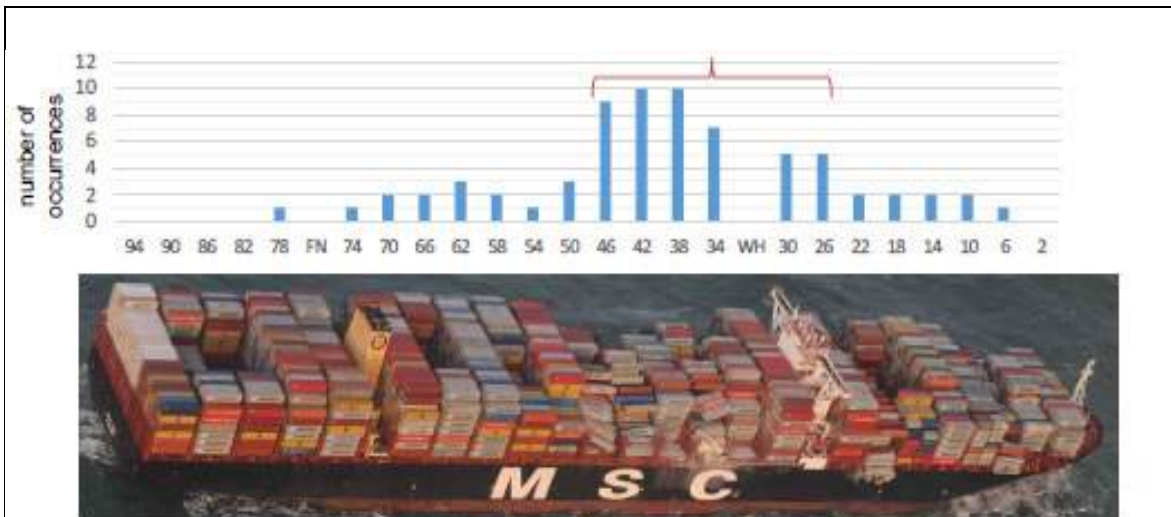
Figure 4-40: Spatial distribution of green water events as observed during three tests at zero speed, compared with the damaged container stacks of the MSC Zoe (view from starboard side)

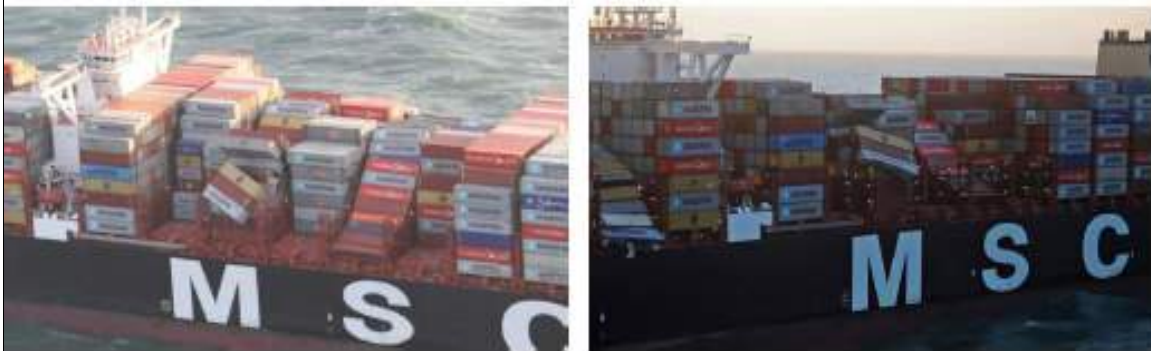
Figure 4-41: Loss of containers on the wave (port) side of the MSC Zoe, in the area where during the model tests the largest number of green water events was observed (view for port side).
