**Konu** : Konteynerlerin Denize Düşerek Zayi Olması  
Olayına İlişkin Kaza İnceleme Raporu

**CODG(21)01**

Members are informed that ICS has been recommended to actively communicate the lessons from the combined investigation report on the MSC ZOE container loss incident, issued by the Panama Maritime Authority, Dutch Safety Board and Federal Bureau of Maritime Casualty Investigation of Germany.

In the late evening of January 1, 2019 and the early morning of January 2, the containership MSC ZOE lost a total of 342 containers whilst sailing on the North Sea, in the Traffic Separation Scheme (TSS) Terschelling - German Bight. The Panamanian flagged ship was en route from Sines, Portugal to Bremerhaven, Germany. At the time of the accident the ship was sailing in conditions with north-northwesterly winds of 8 Bft and waves coming from abeam on port side. The ship was rolling constantly. The crew first detected that cargo had been lost north of the Dutch Wadden Island Schiermonnikoog, at around 01.00 hours local time<sup>1</sup> (LT) on January 2. North of the island Borkum, around 01.30 hours, the loss of containers overboard was witnessed by the crew. The MSC ZOE changed course to

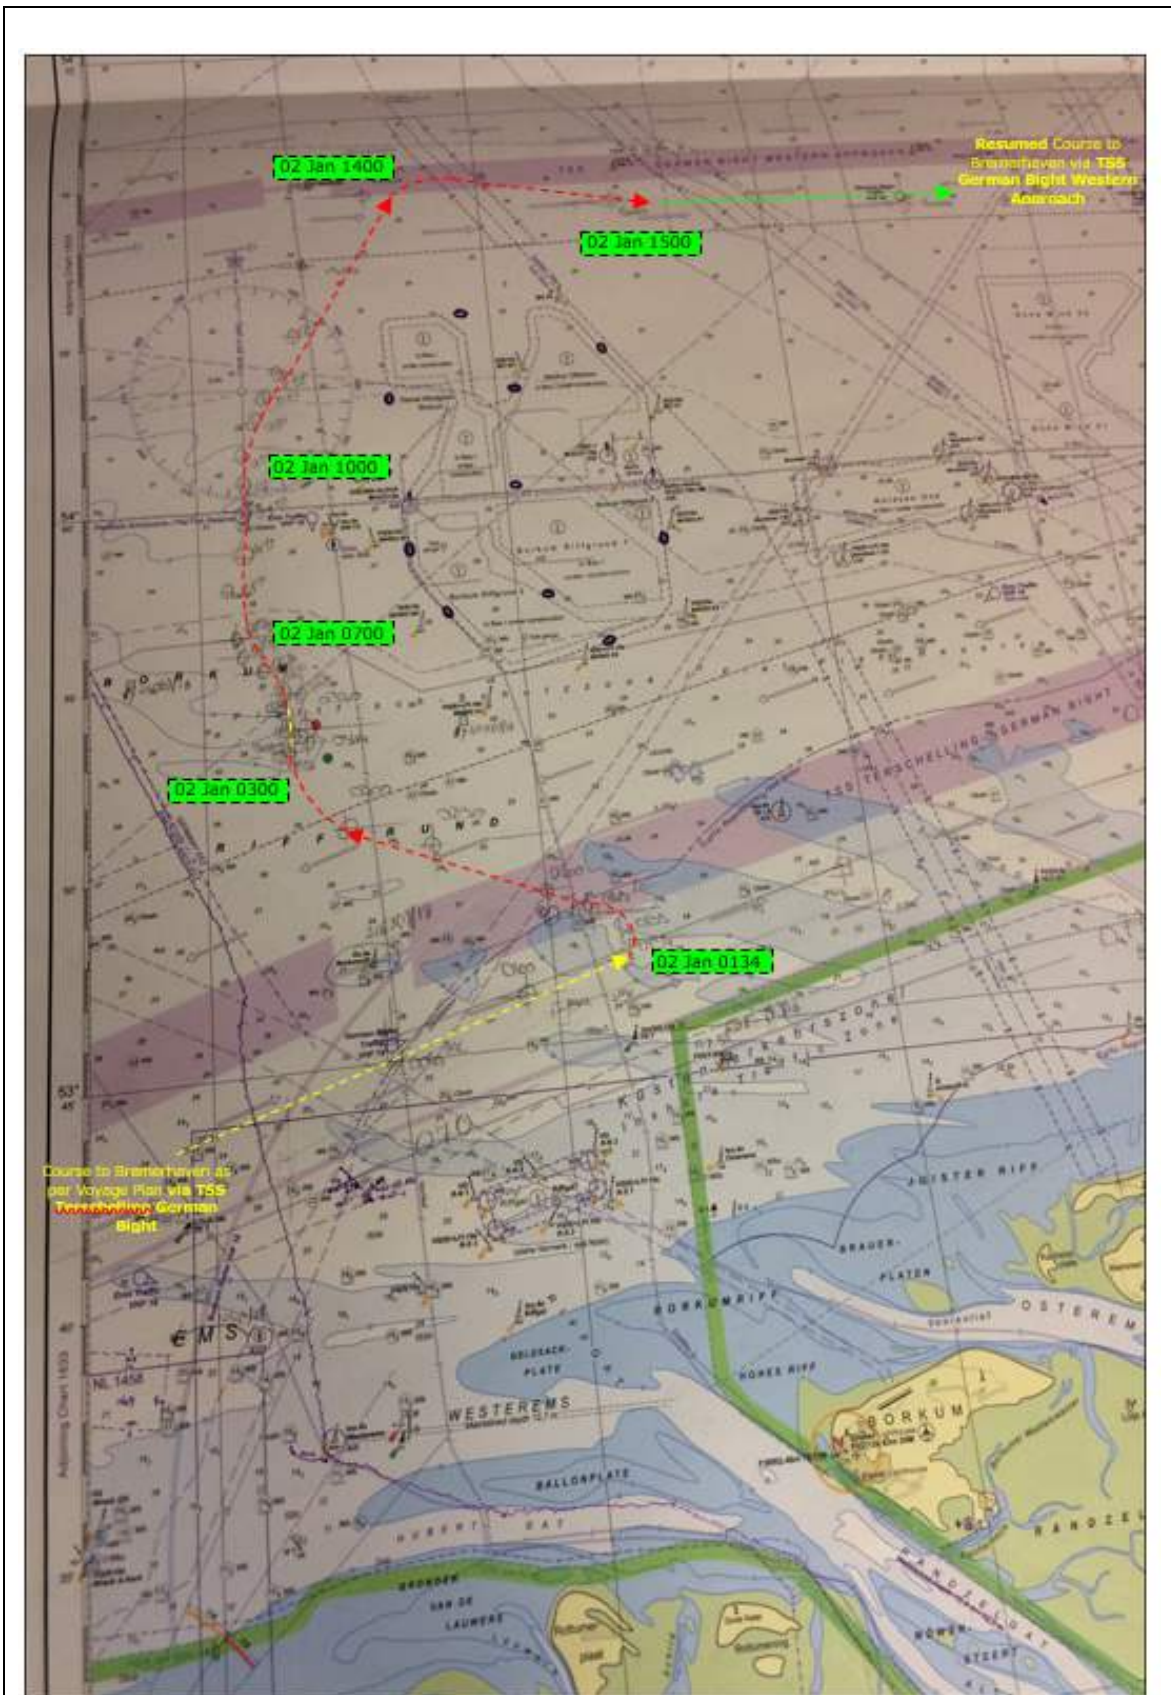
Figure 4: Track of the MSC ZOE after altering course to the north following the detection of the container loss. (Source: Paper chart MSC ZOE)

At around 14.00 hours in the afternoon of 2 January, the MSC ZOE reached the more northerly TSS German Bight Western Approach (see figure 4), and at around 15.00 hours following a turn to starboard, the vessel entered the southern lane in order to continue its journey to Bremerhaven. At 19.15 hours, the pilot came on board, to guide the ship into port. The MSC ZOE moored in Bremerhaven, at 01.00 hours in the morning of 3 January 2019.

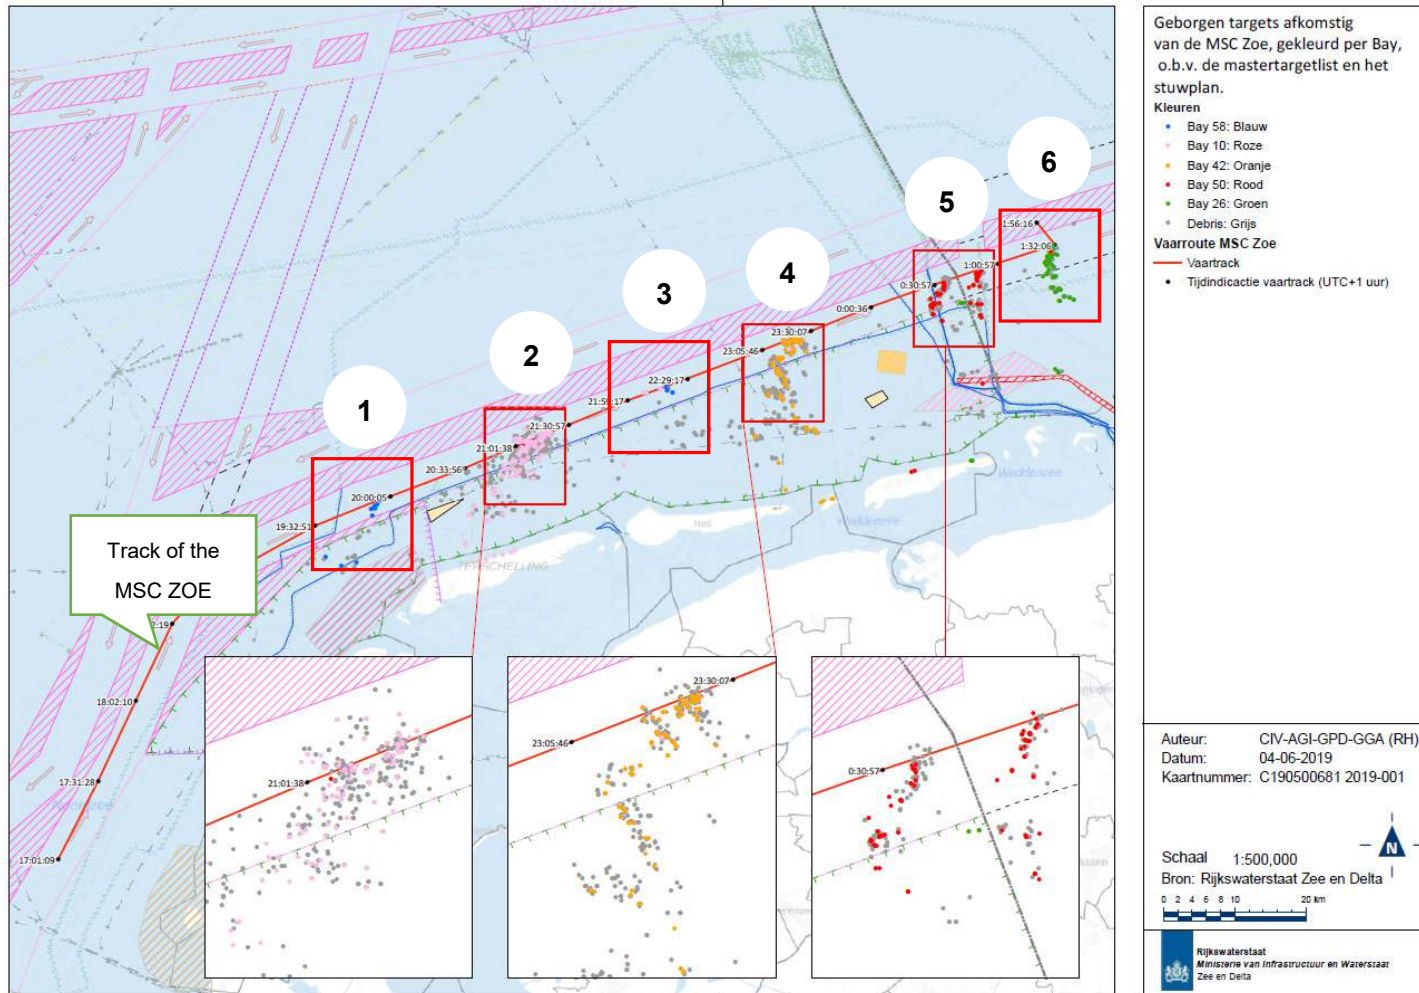
Figure 20. Recovery locations of lost containers. Six main locations can be identified. Colours indicate bay number on board the ship: blue=bay58, pink=bay10, orange=bay42, red=bay50, green=bay26, grey=debris. Track of the MSC ZOE is indicate in red. (Source: Rijkswaterstaat, the six locations added by the investigation team)

Figure 20 shows that large numbers of containers were recovered at six locations. Combining this with the sailing route of the MSC ZOE, it was possible to reconstruct where and when which containers fell overboard. The MSC ZOE lost containers from the bays 10 (9/11) (pink), 26 (green), 42 (orange), 50 (red) and 58 (blue). Bays 46 and 54 also contained damaged containers, but they didn't fall overboard (see chapter 4).

The first containers were lost shortly before 20.00 hours (blue dots in figure 20). At that time, the MSC ZOE was located to the north of the most easterly point of Vlieland. These containers originated from bay 58, in the middle of the ship (see figure 21). The most notable element of this initial loss moment was that all the containers fell over the starboard side (see figure 22).

The second loss of containers occurred between 21.05 and 21.20 hours (pink dots in figure 20). At that time the MSC ZOE was located to the north of Terschelling. These containers originated from bay 10 at the bow of the vessel (see figure 21). Approximately the same number of containers fell overboard from both sides of the vessel (see figure 22).

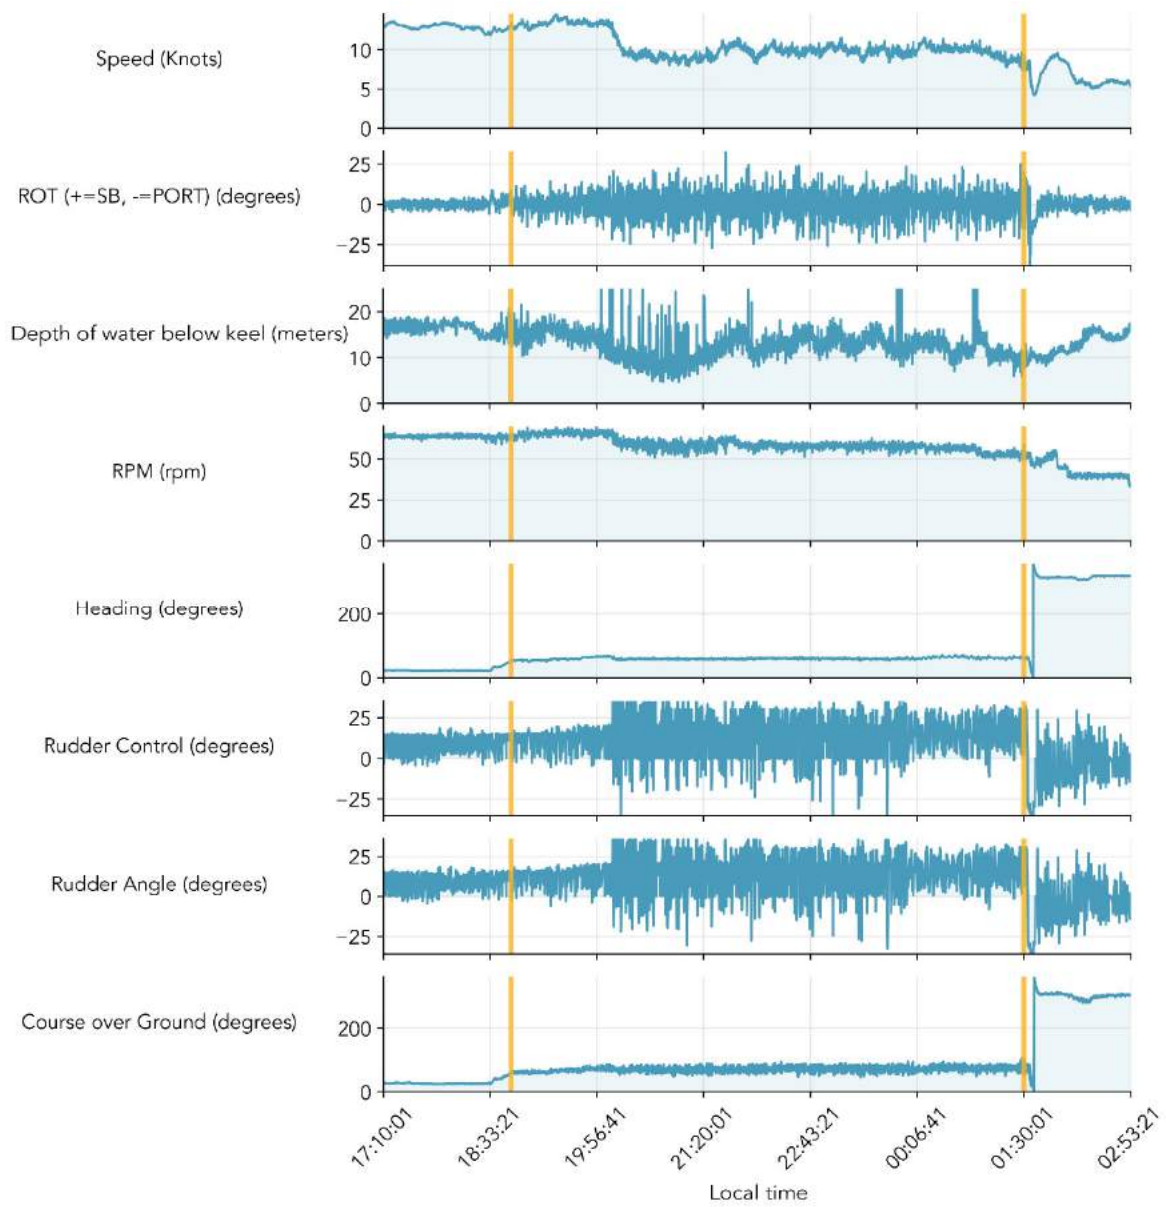
Some noise can be reduced through software, but this is not always possible. In figure 23 the measurement of the echo sounder is shown. It also shows several peaks at 50 or even 100 meters. These are considered noise, since such water depths are not present at that location of the MSC ZOE. Because these peaks start to show up during the time where the roll motion is also increased, it is likely noise (outliers) caused by the roll of the ship or due to the ship's noise which is increased during this part of the voyage.

Figure 23: Selected parameters from the Voyage Data recorder (VDR) in local time.

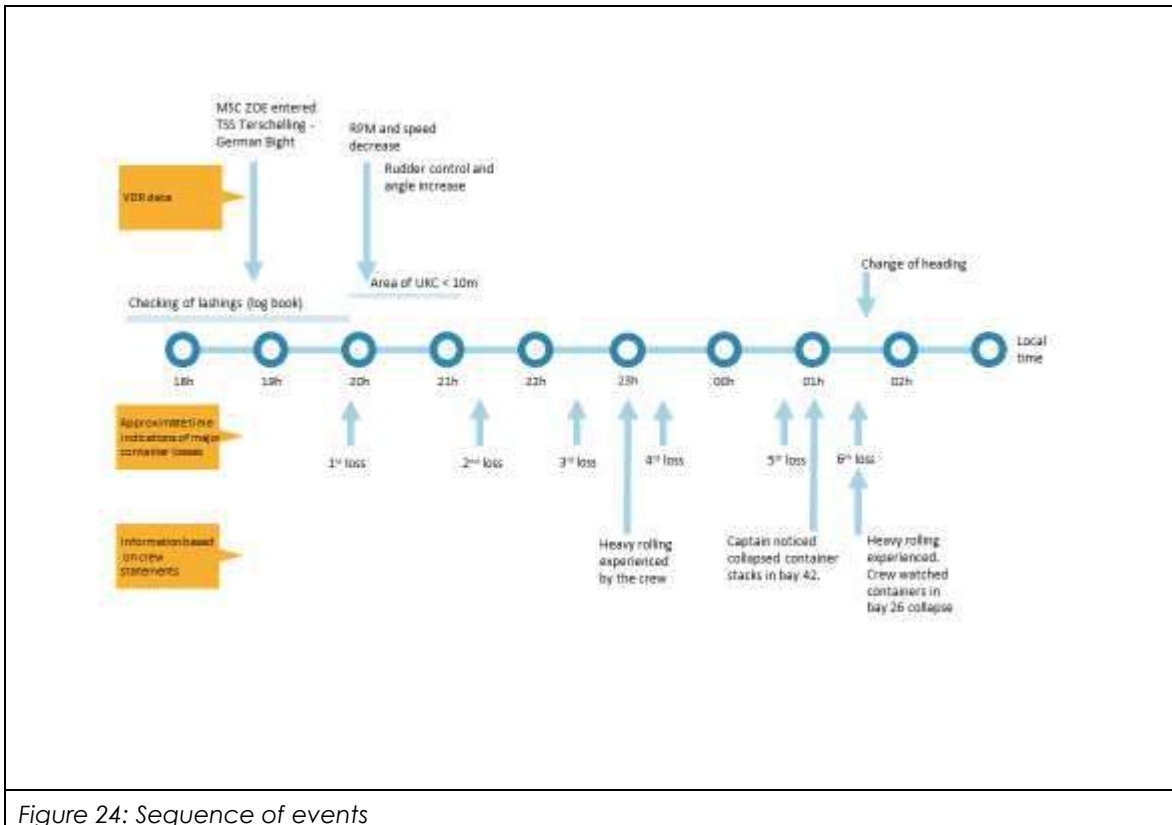
Figure 24 summarizes the sequence of events and combines the data from the VDR, the information based on crew statements regarding the perceived ship motions and the major container loss moments based on the container recovery data.

Figure 24: Sequence of events

According to crew statements, the MSC ZOE experienced in the TSS Terschelling – German Bight continuous rolling movements of 5 and 10° with occasional moments of heavier rolling of 15° up till 30° peaks. The VDR data confirms that when the MSC ZOE entered the TSS Terschelling – German Bight the ship started to roll continuously.

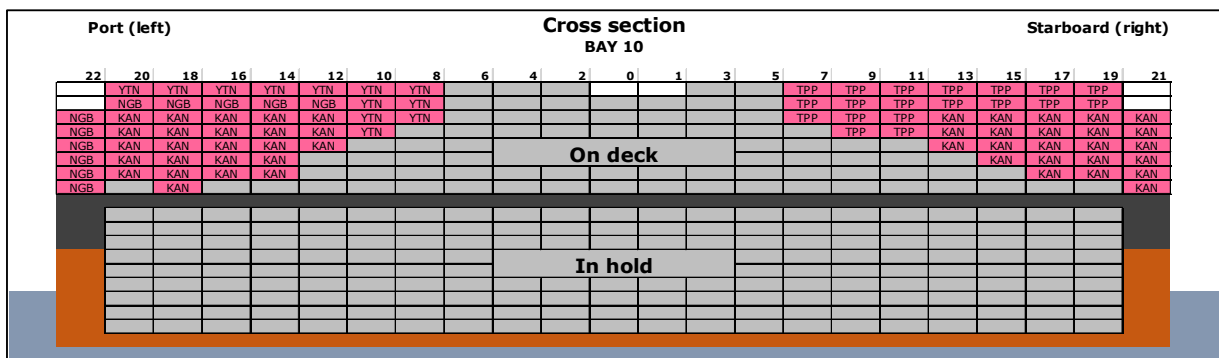
The containers lost from bay 10<sup>24</sup> were loaded in all Asian ports except Xinyang and Shanghai and were destined for Gdansk.

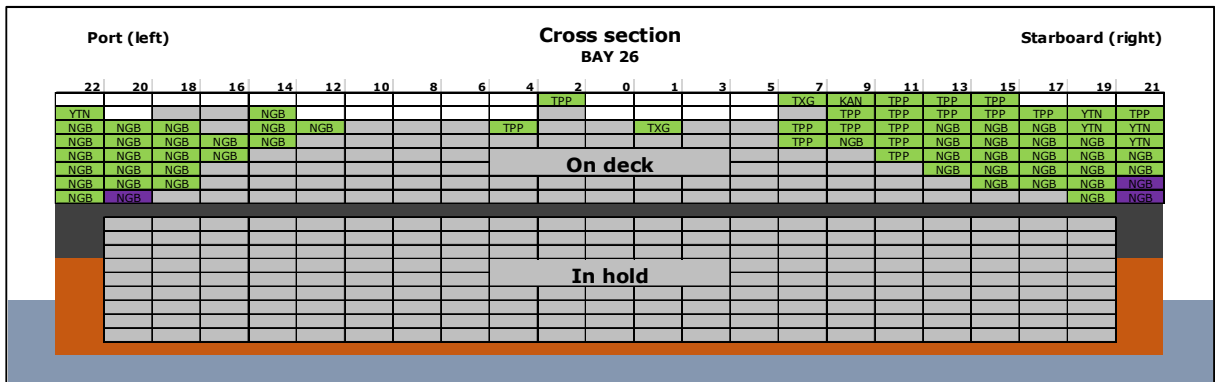
The containers lost from bay 26 were loaded in all Asian ports except Shanghai and destined for Gdansk. Bay 26 contained 3 containers with dangerous goods, coloured purple. The two containers on starboard were lost; the one on port side remained on board but lost some of its content.

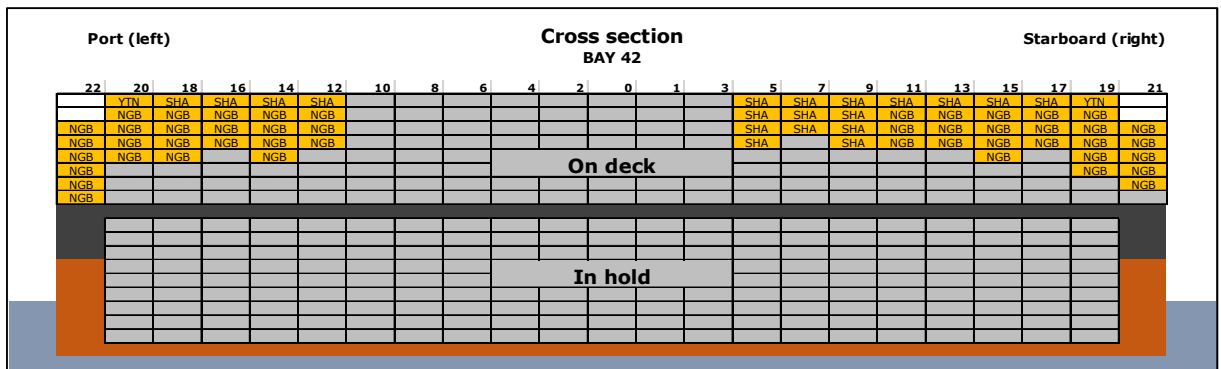
The containers lost from bay 42 were loaded in Ningbo, Shanghai and Yantian and were destined for Gdansk.

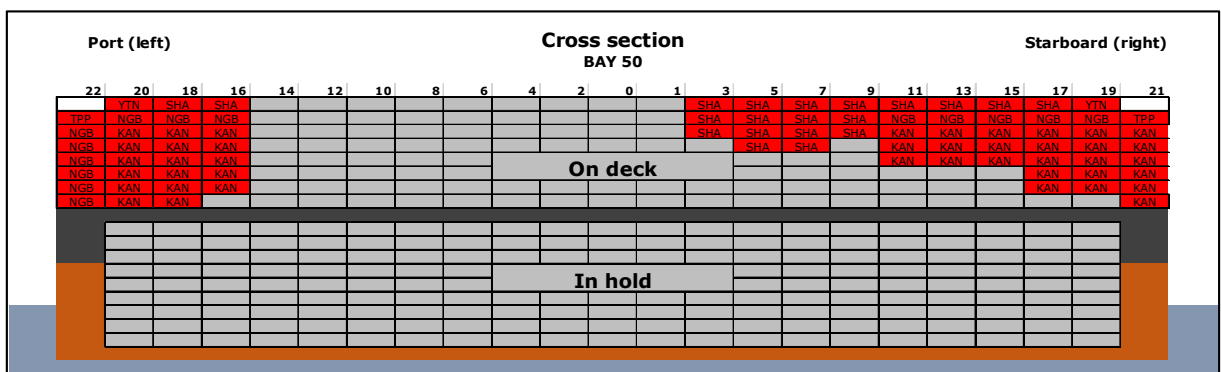
The containers lost from bay 50 were loaded in all Asian ports except Gwangyang and Shanghai and were destined for Gdansk.

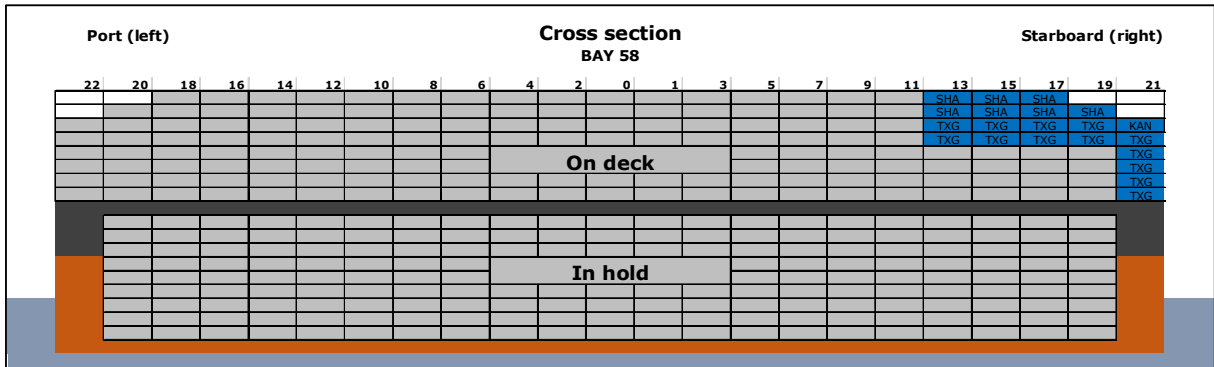
The containers lost from bay 58 were loaded in Xinyang, Gwanyang and Shanghai and destined for Gdansk.

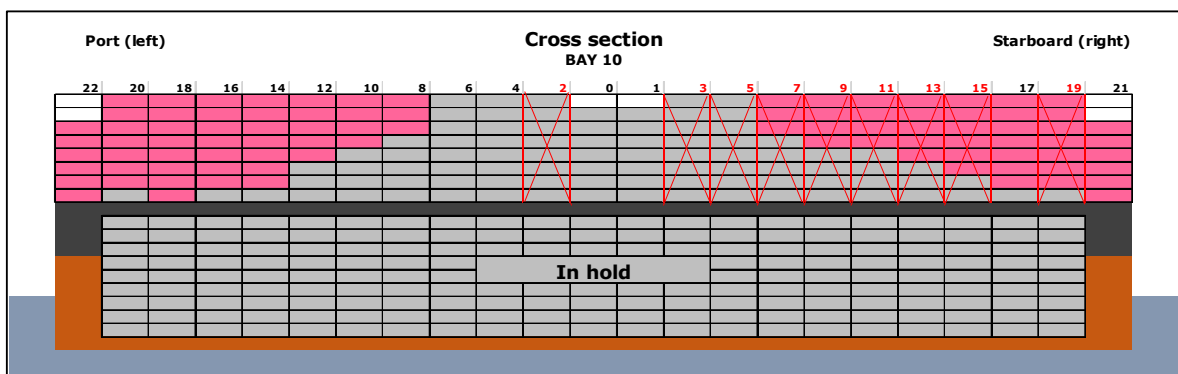
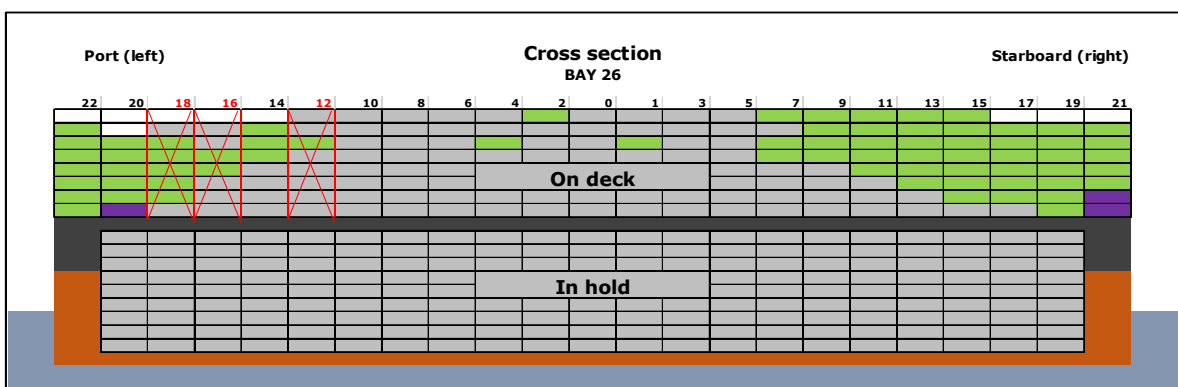
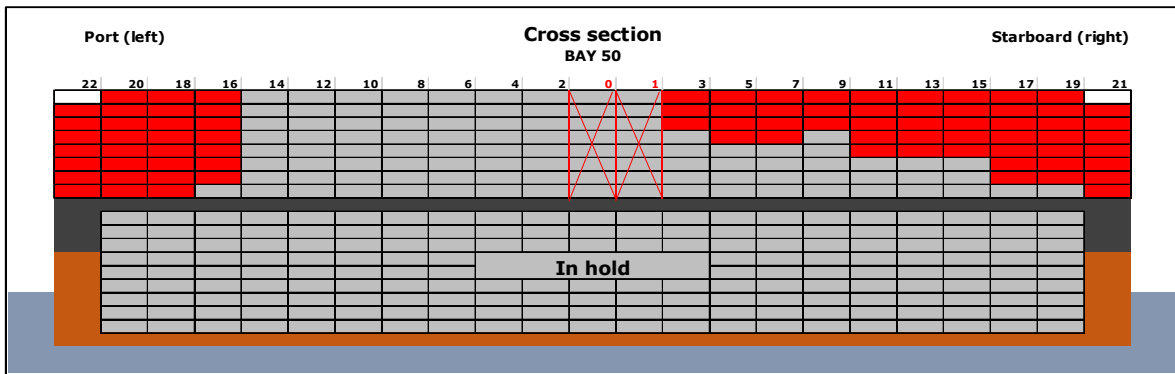
During the on-site investigation in Bremerhaven the loading computer on board the MSC ZOE indicated, for the accident voyage, red warning boxes in bays 10 (9/11), 18, 26, 30, 50, 62 and 70. A red warning box indicates an exceedance of any of the tolerance limit of one of the six possible reasons listed above. The exceedance of the tolerance limits where, however, not further specified. From bay 10 (9/11), 26 and 50, which showed red warning boxes based on the information retrieved in Bremerhaven, containers fell overboard. But bays 42 and 58, where containers also have been lost, did not have any red warning boxes.

Despite the preparation for the voyage from Sines to Bremerhaven, the loading computer on board the MSC ZOE indicated red warning boxes in bays 10 (9/11), 18, 26, 30, 50, 62 and 70. During the safety investigation, it was not possible to determine which limits had been exceeded. In the lashing software of the loading computer the applicable service area can be selected by a tick box (eg *Asia-Europe*). Depending on the area of operation, parameters used for the calculations may differ. MSC provided a simulation with the lashing software based on the loading condition of the accident voyage. The simulation showed a clear difference when ticking the box *Unrestricted service* or *Asia-Europe* in the service area menu. However, the displayed values as seen during the on-site investigation could not be reproduced afterwards, because it was not feasible to retrieve all used settings. MSC states that changing a few tick boxes in the computer may change all the calculations and this could have happened on board the MSC ZOE, since many people had been working on the computer, before the investigators were shown the data in Bremerhaven.

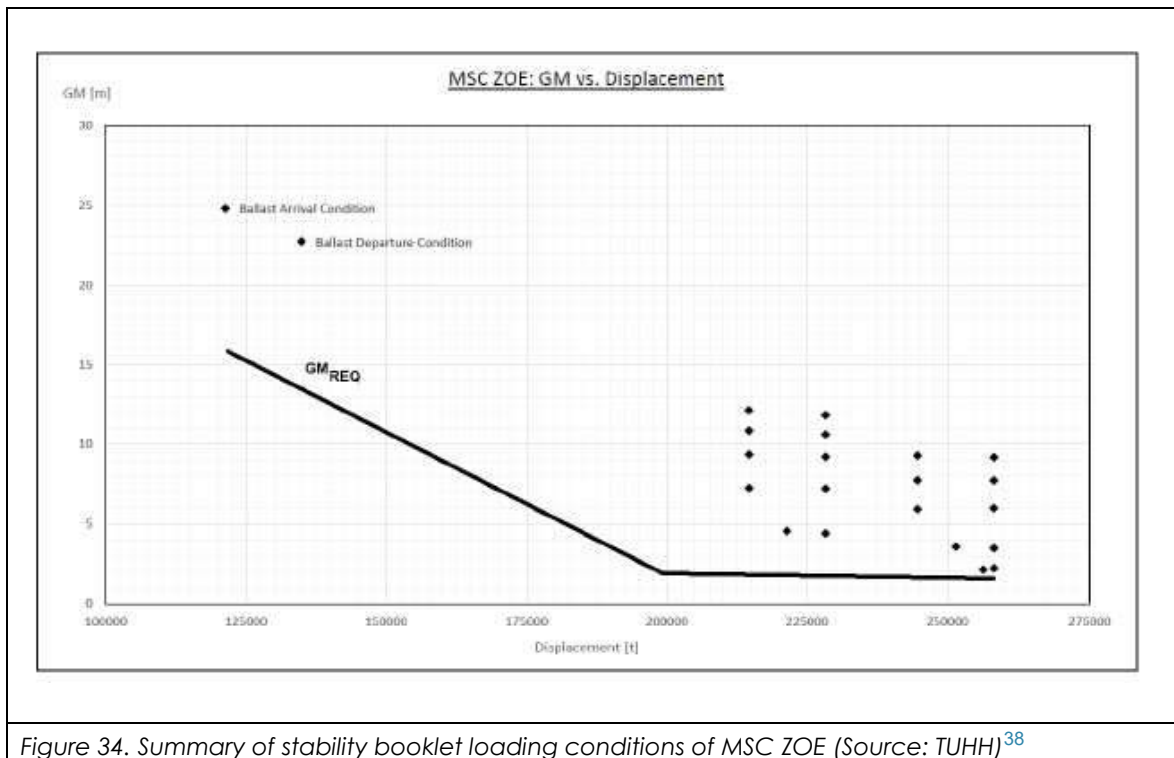
Figure 34. Summary of stability booklet loading conditions of MSC ZOE (Source: TUHH)<sup>38</sup>

The sample conditions in the CSM are based on a GM of  $\leq 2.08$  m, the loading computer on board should be used for any different GM to make the corresponding calculations. The MSC ZOE sailed with a solid<sup>37</sup> GM of 10.23 m which was corrected for (partly) filled tanks, the so-called free surface correction. The corrected GM of 9.01 m was used in the loading computer. Thus the MSC ZOE sailed with a high stability.

The table from the stability booklet confirms that although a solid GM of 10.23 is considered a high value, this was not an unusual condition for the MSC ZOE (see figure 34).

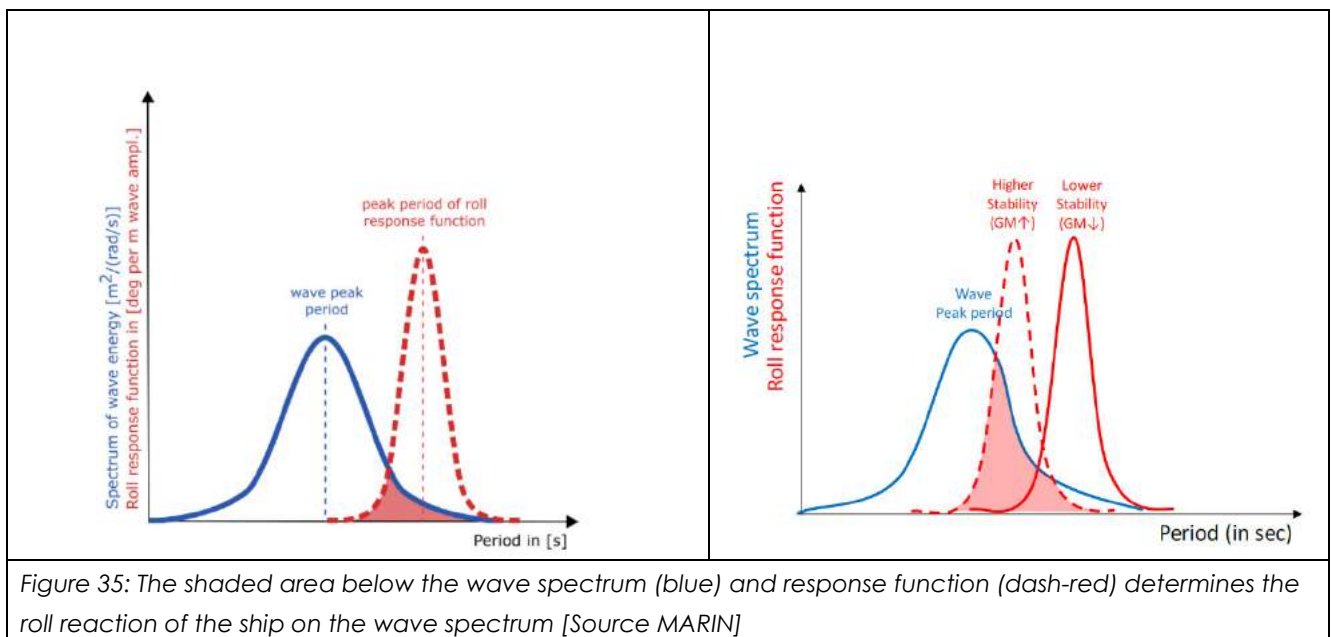
Figure 35: The shaded area below the wave spectrum (blue) and response function (dash-red) determines the roll reaction of the ship on the wave spectrum [Source MARIN]

As with all mechanical systems, a resonance situation will occur if the excitation period approaches the natural period of the ship. Figure 35 depicts an example wave spectrum and roll response function of a ship. The roll reaction of the ship will increase when the peak of ship's roll response function is closer to the peak wave period encountered.

A ship's GM has an effect on this roll response function. MARIN states in its report (Appendix D) that present-day ULCSs show relatively high stability in roll because of their large beam and a fairly low position of the centre of gravity due to the stowage plans applied. As a result, these type of ships are more likely to show a higher roll response to wave periods present in the North Sea north of the Wadden Islands.

As a result of the higher roll response, strong ship movements lead to large accelerations on the containers and lashing systems on the deck of the ship. The lashing systems present on ULCS container ships are the same as on all other types of container ships however, the lashing system (configuration) should take the larger accelerations into account.

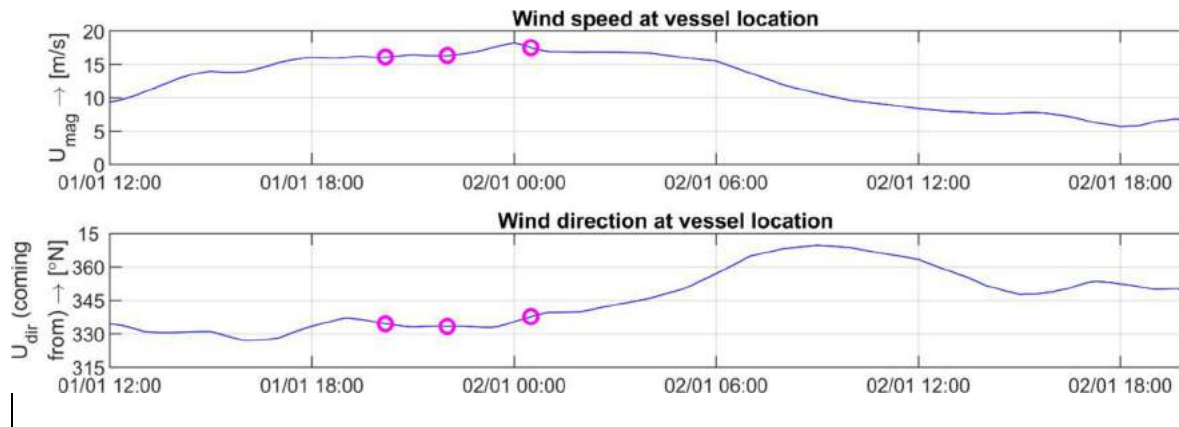
Figure 37: Modelled wind speed and wind direction along the route of MSC ZOE.

Modelled wind speed and wind direction along the route of the MSC ZOE are depicted in figure 37. On January 1, the wind direction changed gradually from west to north-northwest. The wind speed increased during the day. At the time of the peak of the storm (around 01.00 hours LT on January 2), the MSC ZOE passed north of Schiermonnikoog.

The wind speeds encountered by the MSC ZOE in the TSS Terschelling – German Bight were between 16-18 m/s (up to 8 Bft) with gusts of wind force two over the mean. The peak of the storm occurred around 01.00 hours LT on January 2. The wind approached the ship from abeam. The encountered heavy conditions are neither extreme nor exceptional for this part of the North Sea.

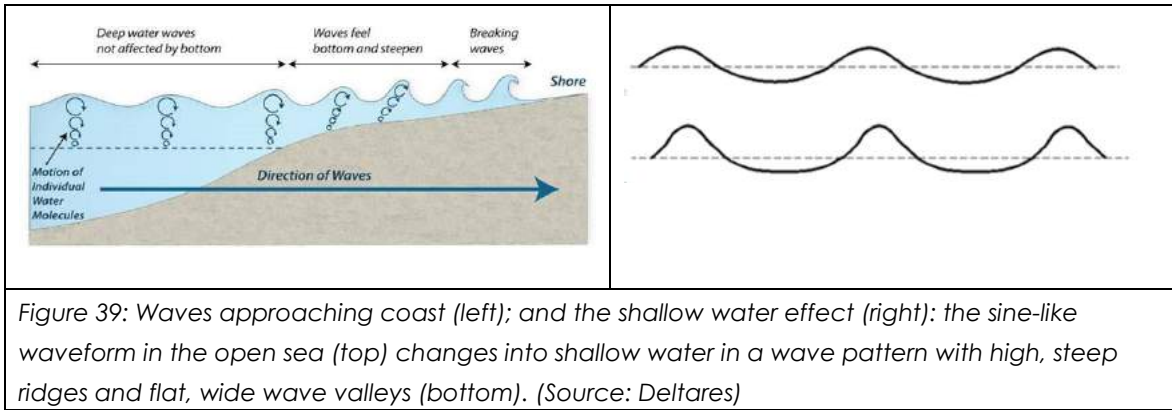
Figure 39: Waves approaching coast (left); and the shallow water effect (right): the sine-like waveform in the open sea (top) changes into shallow water in a wave pattern with high, steep ridges and flat, wide wave valleys (bottom). (Source: Deltares)

In shallow water, the waves experience the influence of the sea bottom. When a wave approaches the shallower depths in the vicinity of the coastline, non-linear shallow-water effects will influence the shape of the waves. This causes a steepening of the crest and a reduction (and stretching) of the troughs, see figure 39.<sup>44</sup> Breaking or white-capping is more likely to occur for steep waves in shallow water than for less steep waves in deep water. In these shallow water conditions, steep waves occur that can break forward with high velocity at the crest.

Deltares also concludes that the local wave conditions were influenced by the shallower depths. Particularly the highest and longest waves will have shown steepened and heightened crests and flattened troughs. Non-linear wave behaviour such as white-capping due to the steepened crests did occur along the sailing route, resulting in more complex wave conditions compared to deep water linear waves.

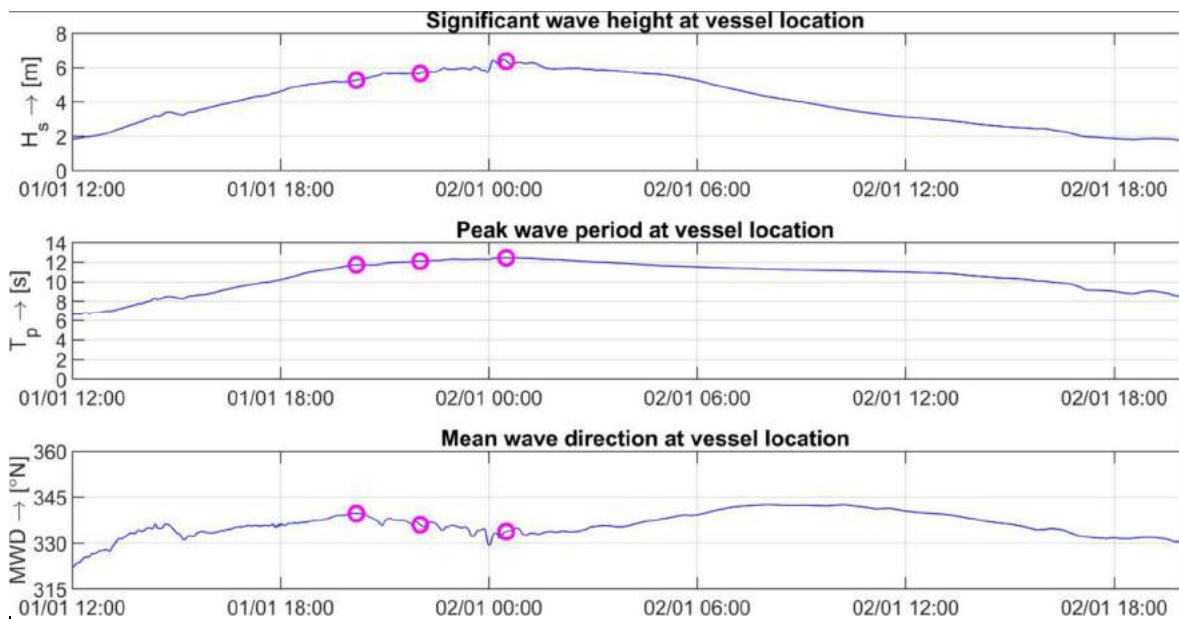
Figure 40: Wave conditions along the route of the MSC ZOE.

Deltares modelled the wave conditions encountered by the MSC ZOE when it was sailing in the TSS Terschelling – German Bight based on, among other sources, information of three wave buoy and five offshore platforms, see figure 40. The wave height that the MSC ZOE encountered developed with the increasing wind speed. On January 1 at around 15.00 hours LT, at the time that the ship was sailing along the Dutch west coast, the significant wave height ( $H_s$ ) was 2.5 meters. Five hours later, at 20.00 hours, the significant wave height ( $H_s$ ) was around 5.2 meters. The ship experienced the largest waves with a significant wave height of 6.5 meters at approximately 01.00 hours on January 2, after passing the island of Schiermonnikoog. The peak wave period ( $T_p$ ) experienced during the moments of container loss (between 20:00 hours and 01:30 hours LT) were between 11.8 and 12.5 seconds.

Deltares has performed a statistical analysis on how often these values in the North Sea are exceeded. The wave conditions as a result of the storm are exceeded on average one to two times in a year. These conditions can be considered to be neither very extreme nor exceptional.<sup>46</sup>

The waves approached the MSC ZOE from abeam. This wind direction allows the waves to build up as there is a long fetch length available on the North Sea. Significant wave height increased from 5 m to 6.5 m at the peak of the storm. The maximum wave height during this time reached up to around 11 meters. The peak wave period encountered was approximately 11.8 - 12.5 seconds. The wave conditions are neither very extreme nor exceptional for this part of the North Sea.

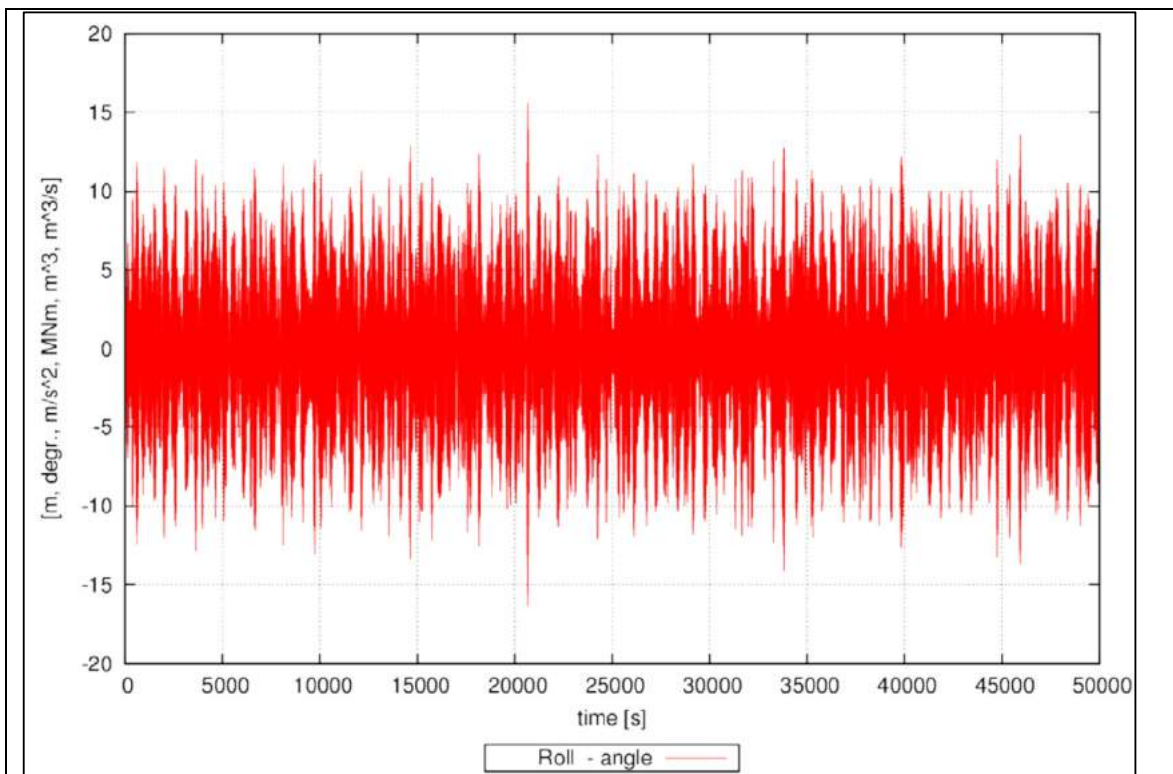
Figure 45: Computed time series of the roll angle of MSC ZOE. Accident condition, speed 10 kn, encounter angle 93°, 50000 s simulation time (Source: TUHH)

The TUHH performed numerical simulations to calculate the roll motions for the MSC ZOE at the time of the accident. Results of the simulation show the vessel permanently rolling with roll amplitudes between 5 and 10°, see figure 45. It also shows that at one time, a roll angle of around 16° occurs. According to TUHH, this roll angle may be the result of a group of larger waves hitting the ship.

Calculations by the TUHH of the effect of the beam wind on the roll motion indicate that the effect is limited. As the stability of the ship is very high, the wind force will not lead to a significant increase of the roll angle. The calculation including the wind heeling moment showed an increase of the maximum roll from 16.3° to 16.9°.

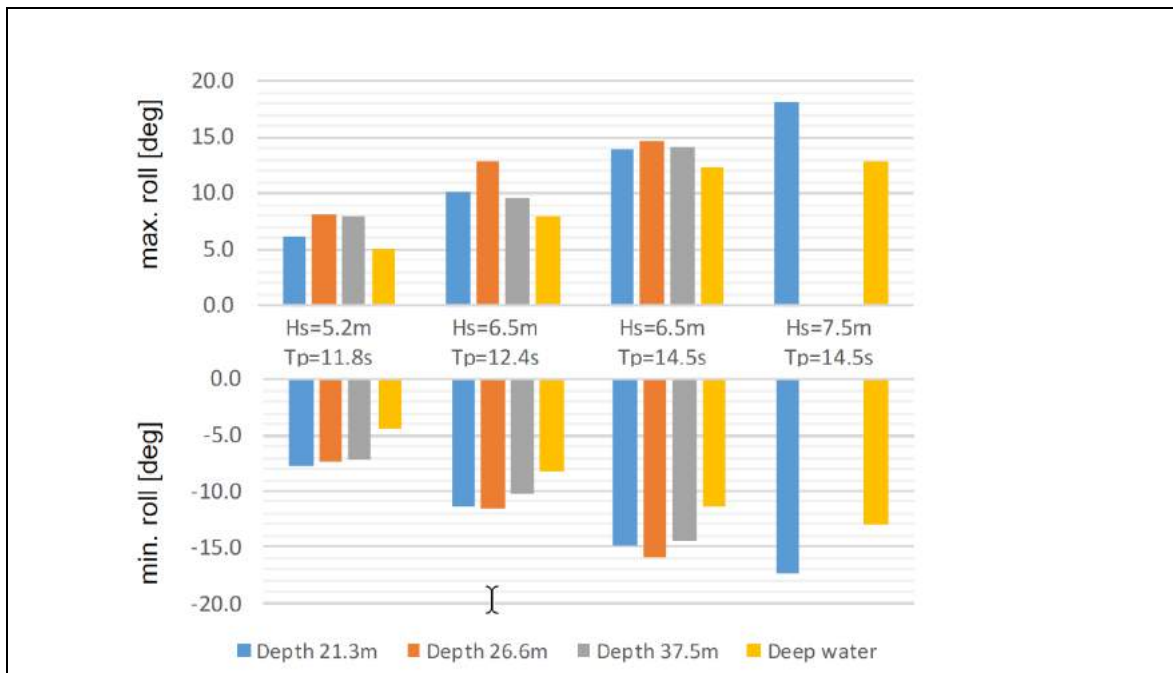
Figure 46: Extreme amplitudes of roll  $V_s = 0$  kn, short-crested waves (Source MARIN)  
 Note: tests in waves of height 7.5m were only performed for depths 21.3m and deep water.

Similar results for UCLS in general were obtained from the basin tests performed by MARIN. The basin tests were conducted with variations in the significant wave height  $H_s$  and wave period  $T_p$ . The measured extreme roll amplitudes increase with an increase in  $H_s$  and  $T_p$ , see figure 46. For a significant wave height of 6.5m and a water depth of 26.6m, the largest roll amplitude measured was around 16°.

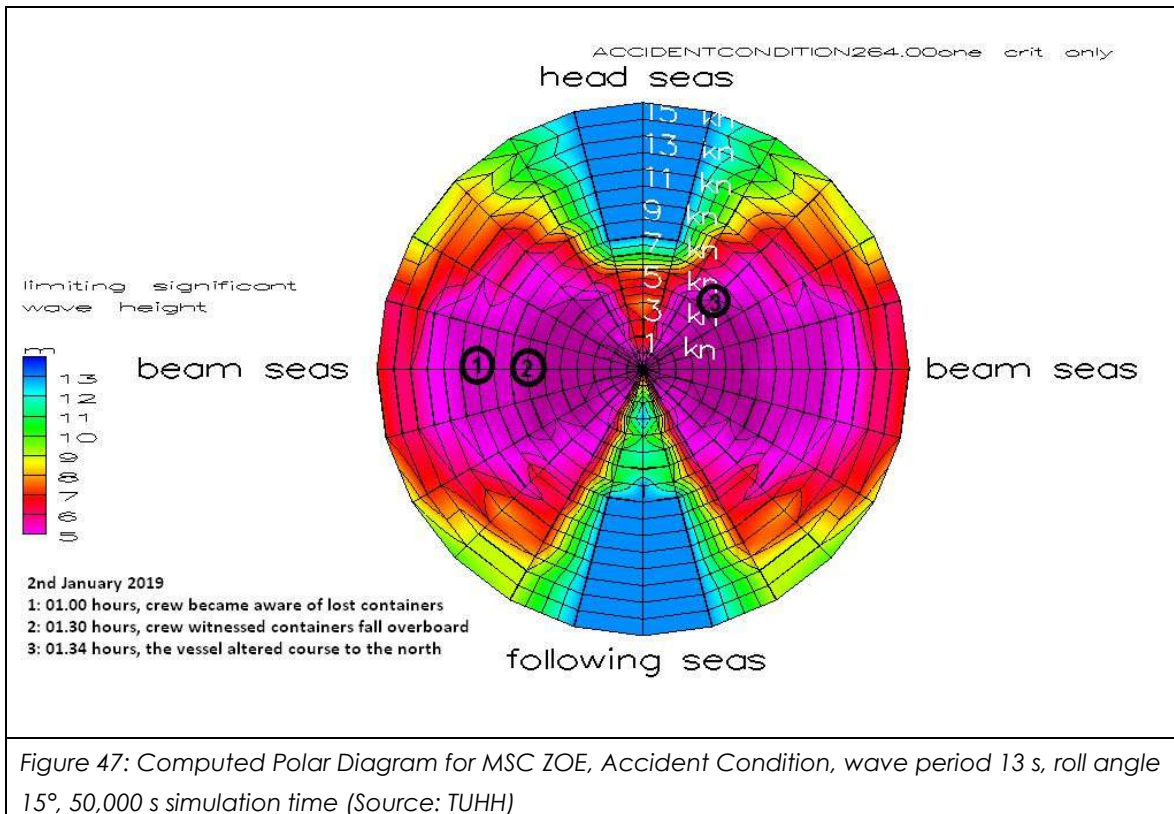
The TUHH calculated the limiting (minimum) significant wave height for a roll amplitude of 15° in waves with a peak period of 13s on different courses, see figure 47. The results show that for the MSC ZOE the beam sea scenario was unfavourable for roll motion under the conditions encountered. The ship is assumed to be in the center of the polar plot. The radial rings represent the ship speed; the sectors indicate the encounter angle of the waves. It can be concluded that a 15° roll amplitude is reached in beam seas in all speeds already for significant wave heights of about 5 m. For all other courses, much larger wave heights are required to reach the 15° roll amplitude. As an example, two moments along the sailing route of the MSC ZOE are presented in the figure (situation 1 and 2 in figure 47). It further shows that also in bow quartering seas, comparable roll angles are possible for wave encounter angles slightly above 30° and slow speed (example situation 3 in figure 47).

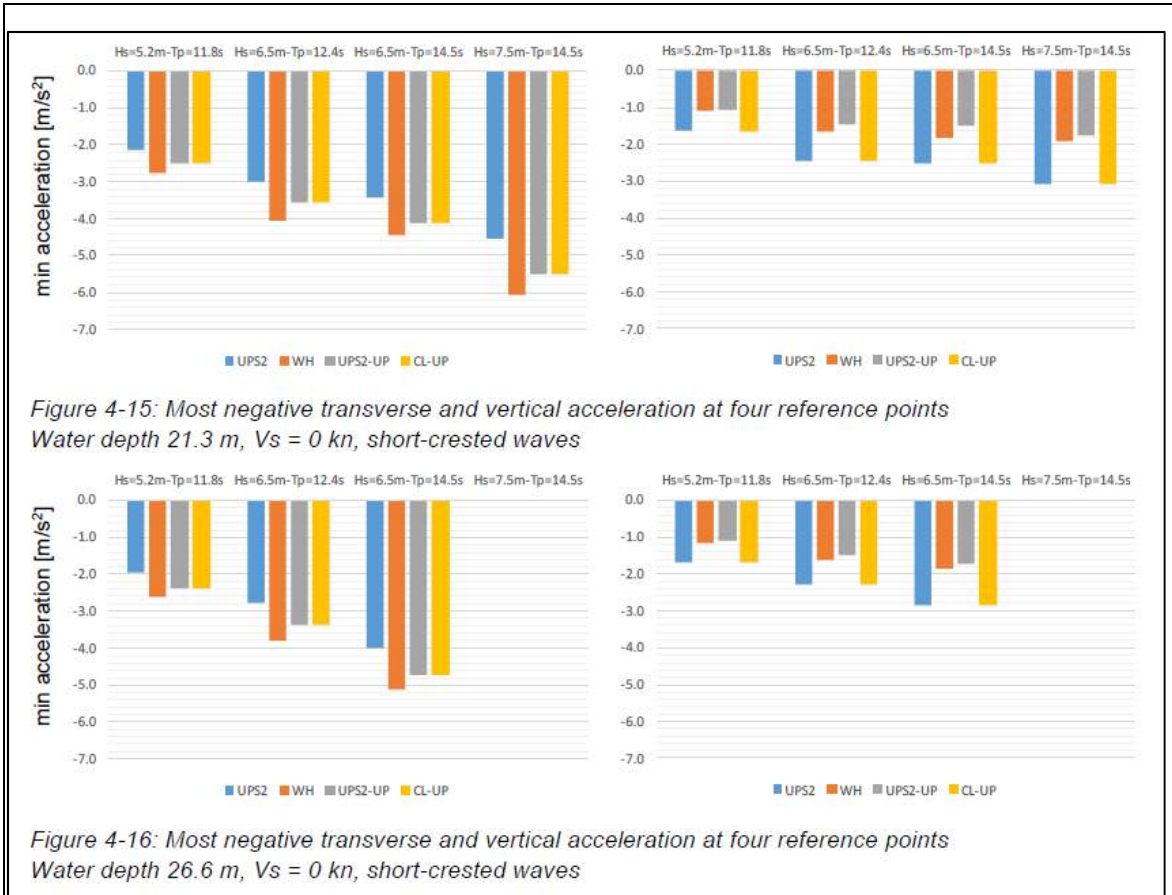
Figure 50: Most negative transverse and vertical accelerations at four reference points. (Source: MARIN)

Considering the water depth the MSC ZOE encountered, the MARIN results for water depths of 21.3m and 26.6m are depicted below. The highest transverse accelerations in wave heights up to 6.5 m ( $T_p=14.5 \text{ s}$ , water depth 26.6 m) reached  $4.0 \text{ m/s}^2$  at the lowest

tier of containers on deck, 4.8 m/s<sup>2</sup> at the top of tier 7 and exceeded 5 m/s<sup>2</sup> at the wheelhouse, see figure 50. Overall it can be stated that the transversal accelerations increase with the height on deck due to the effect of roll. Accelerations are also found to be larger at a water depth of 26.6m, following the trend of roll (higher maximum roll angle in water depth of 26.6 m compared to 21.3 m).

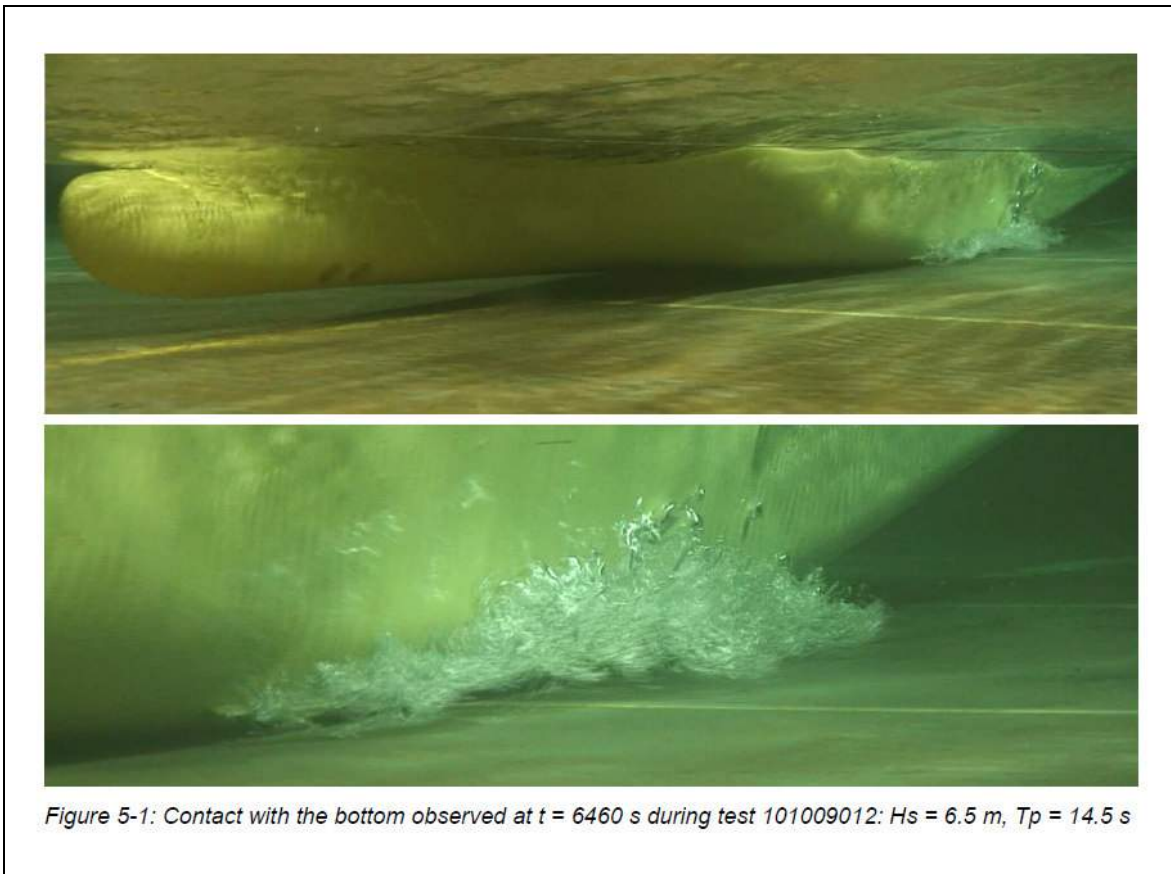
During the tests in the basin, contact or near contact of the model ship with the floor of basin was observed (see figure 51). The frequency of this varied with the wave and ship conditions. During the tests with short-crested waves contact with the basin floor was observed at a water depth of 21.3 m and a wave height of 6.5 meters and above and a peak period of 14.5 meters. The analysis by MARIN of the ship's motions shows that the model can touch the basin bottom when a large vertical heave motion is combined with a large roll motion at the same time in the passage of a group of relatively high waves. The ship also makes a transverse sway motion at that time.

Figure 51: Underwater images of the model ship at the moment of bottom contact (water depth 21,3 meter,  $H_s=6.5m$ ,  $T_p=14.5s$ ,  $V_s=0kn$ ). (Source: MARIN)

Basin tests showed that when a group of relatively high waves passed, the ship model experienced large vertical heave motions with a large roll motion at the same time, resulting in near contact or in some cases contact with the floor of the basin. A contact of the ship with the bottom does not necessarily lead to structural damage. Nevertheless, it will be the cause of vibrations and deformations that will be propagated to the whole structure due to the flexural response of the ship.

Along its route in the TSS Terschelling – German Bight, the MSC ZOE has encountered extremely small clearance between the lowest point of the hull and the seabed along its route. A diver's survey carried out as part of the class society's inspection did not reveal any detectable damage to ship's bottom and bilge areas caused by grounding. However, contact of the hull with the sea bottom cannot be ruled out, as soft contact with the sea bottom will not necessarily cause detectable damage to the ship.
