**Konu** : Konteynerlerin Denize Düşerek Zayi Olması  
Olayına İlişkin Kaza İnceleme Raporu

**CODG(21)01**

Members are informed that ICS has been recommended to actively communicate the lessons from the combined investigation report on the MSC ZOE container loss incident, issued by the Panama Maritime Authority, Dutch Safety Board and Federal Bureau of Maritime Casualty Investigation of Germany.

In the late evening of January 1, 2019 and the early morning of January 2, the containership MSC ZOE lost a total of 342 containers whilst sailing on the North Sea, in the Traffic Separation Scheme (TSS) Terschelling - German Bight. The Panamanian flagged ship was en route from Sines, Portugal to Bremerhaven, Germany. At the time of the accident the ship was sailing in conditions with north-northwesterly winds of 8 Bft and waves coming from abeam on port side. The ship was rolling constantly. The crew first detected that cargo had been lost north of the Dutch Wadden Island Schiermonnikoog, at around 01.00 hours local time<sup>1</sup> (LT) on January 2. North of the island Borkum, around 01.30 hours, the loss of containers overboard was witnessed by the crew. The MSC ZOE changed course to

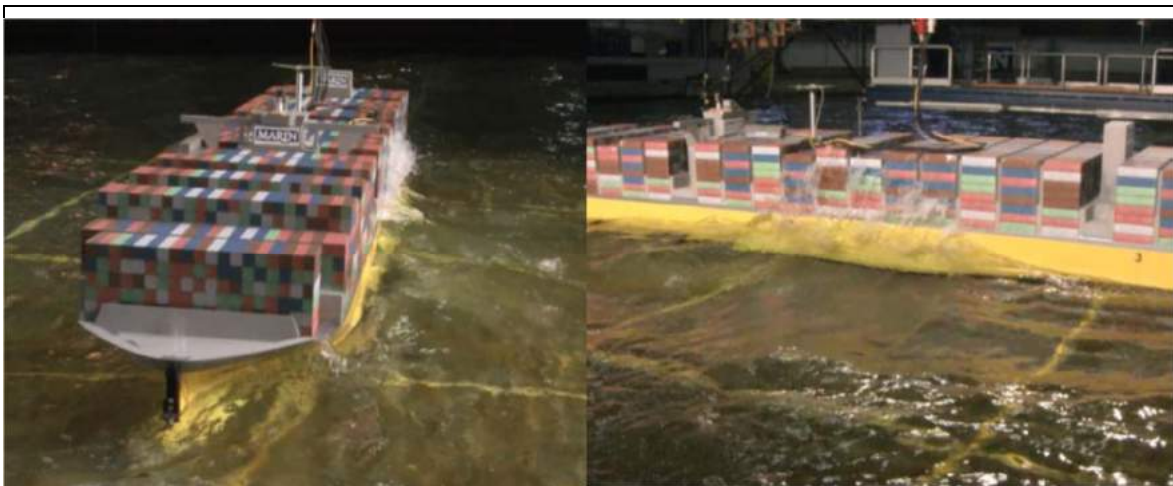
For a container ship, green water has the effect of exerting direct force from the wave on a container. The upwardly directed water can reach above the deck of the ship and can hit the bottom of the lowest containers above the gangway. This can lead to several problems: the bottom containers can be damaged themselves, or containers can be lifted causing damage to the lashings. If one container is damaged or has broken lashings, a whole stack of containers can fall over. The green water can also cause a lateral force on higher-lying containers, so that the container pushes against the container in the next row. This can lead to (part of) a row of containers falling over like a domino.

Figure 52: Images of the ship model and green water effects (source MARIN).

During the basin tests, green water effects were visually observed (using video recordings) for the tested shallow water conditions. Considering the cumulative number of events as observed during the three test conditions, green water was mostly concentrated on six container bays around the wheelhouse (bays 26 to 46). As shown in figure 53, this is in this area where most of the containers on the MSC ZOE were damaged or lost. Although no green water load measurements have been taken in the present tests, this suggests that green water can play a role in the loss of containers in the tested conditions.

The occurrence of green water was observed during the basin tests. Although no green water load measurements were taken during the basin tests, occurrences of the phenomenon were counted visually, using the video recordings. The comparison with the situation on board the MSC ZOE after the accident, suggest green water might have played a role in the loss of the containers.

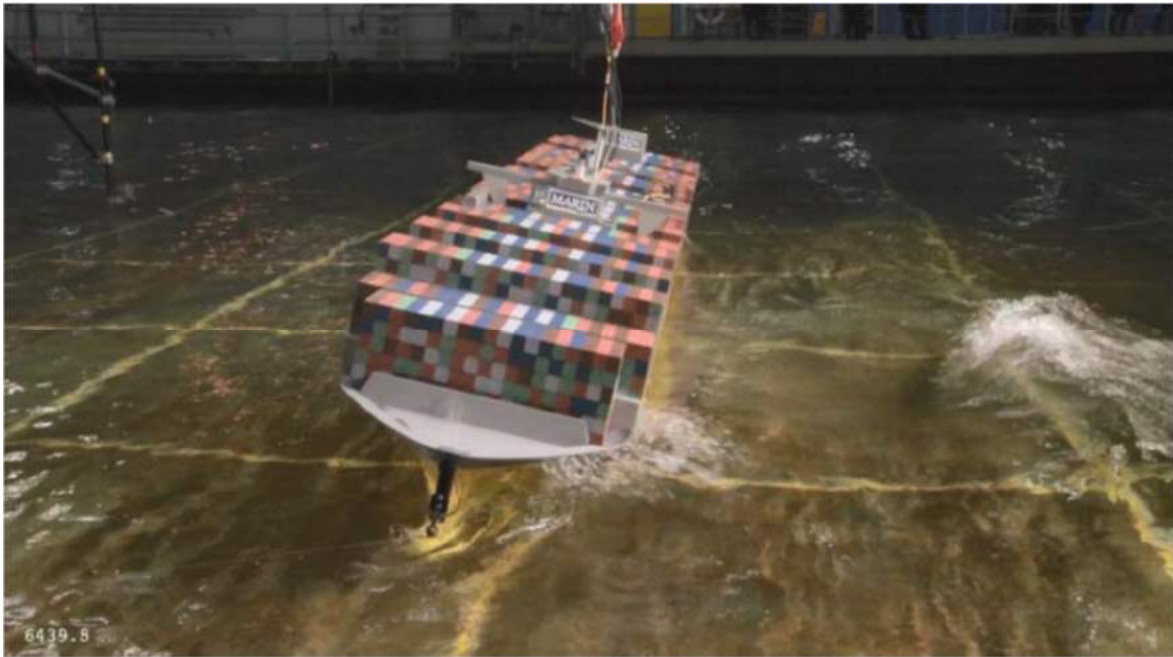
The phenomenon of wave impacts is of the order of magnitude twice as much as green water. The ship model vibrated due to the wave impact. . These vibrations create forces on the frame of the containers and the lashing systems and there is a chance that the lashing systems will break and that containers will fall overboard.

Figure 54: Images of modelship at the moment of slamming (source MARIN)

Slamming was observed in the test for the conditions that were encountered by the MSC ZOE. Impulsive wave loads can result in vibrations in the hull and consequently can create forces in containers and the lashing system.

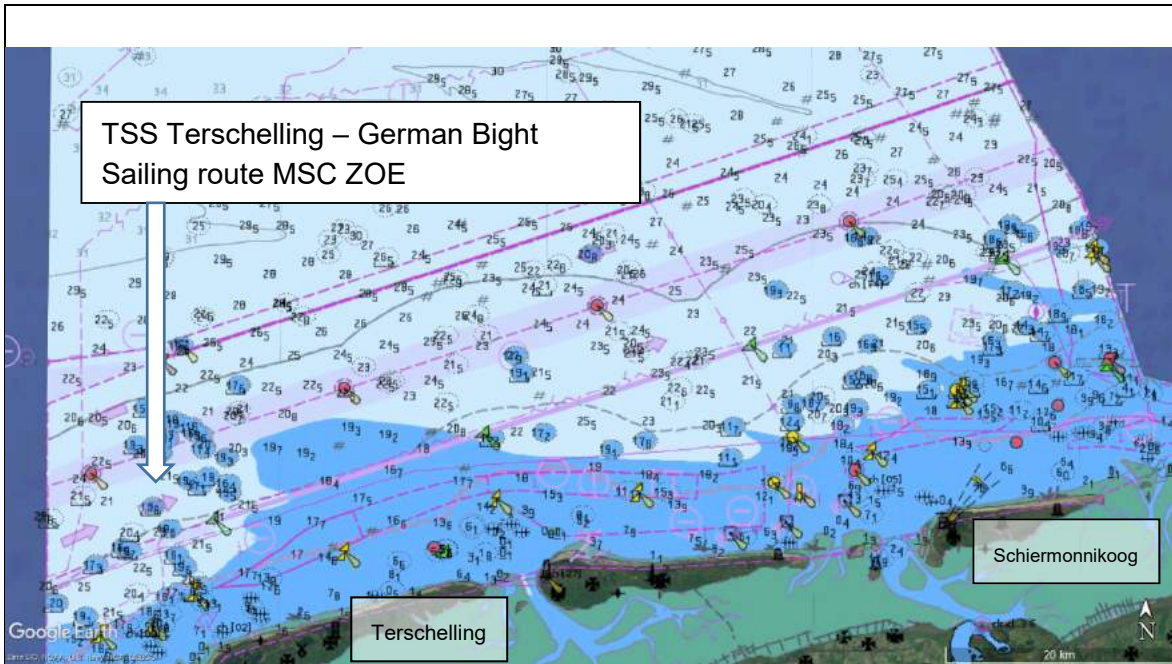
The TSS Terschelling - German Bight has a few shallower areas that are indicated on the navigational charts, see figure 55 below. In order to calculate the remaining Under Keel Clearance (UKC) for the ship, the static draught, water depth, tide, squat and heel angle are to be taken into account. The passage plan of the MSC ZOE for the journey from Sines to Bremerhaven indicates that the ship had a static draught of 12.6 m forward, 12.6 m amid and 12.7 m aft. The passage plan also indicates that at least 4 meter UKC should be kept at all times. A general remark is made on the plan that speed and heel angle may cause an increase of draught.

Figure 56. Navigational Chart, depth in meters, approximately the level of lowest astronomical tide (LAT). (Source: iChart).

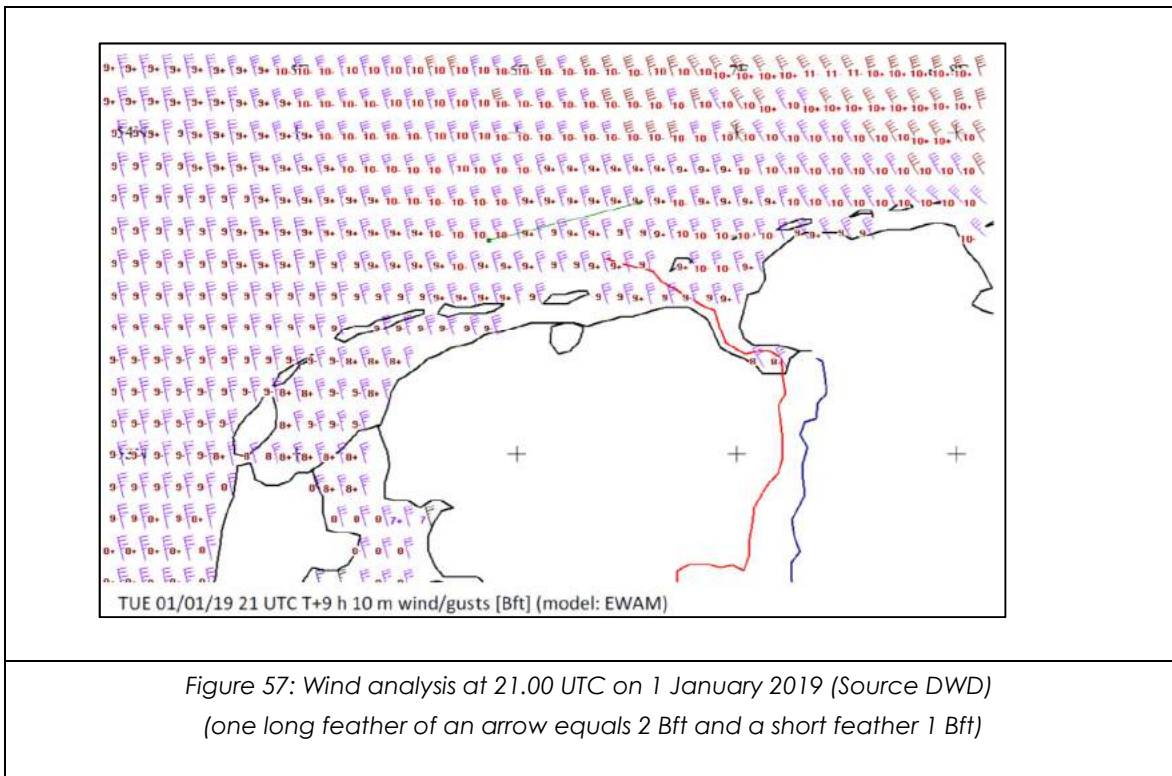
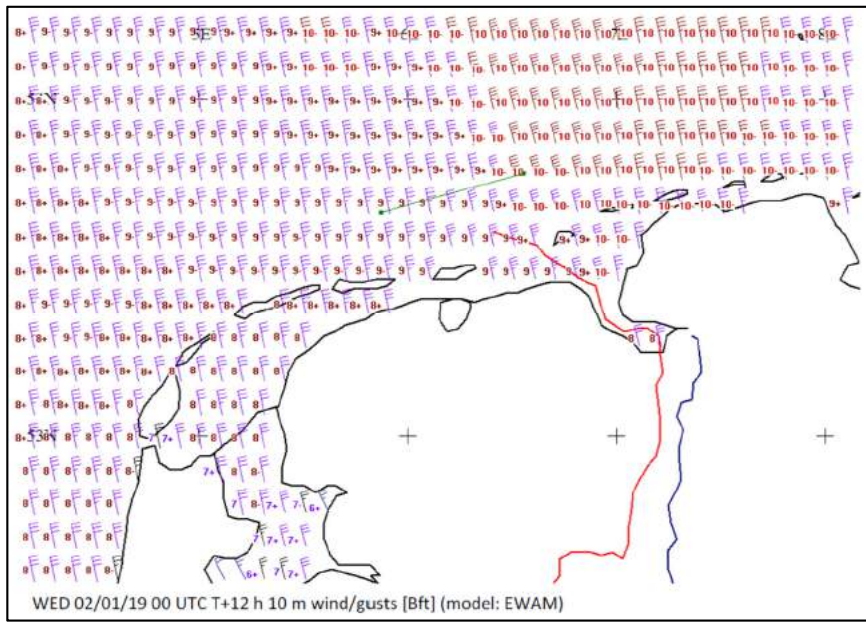
The wind analysis charts in figures 57 and 58 show the wind forces thus obtained in the accident area at respectively 21.00 UTC and 00.00 UTC, with the feathers representing the mean wind and the numerical value the gusts in Bft. The green line shows the course of the MSC ZOE in the period considered.

Figure 58: Wind analysis at 00.00 UTC on 1 January 2019 (Source DWD)  
 (one long feather of an arrow equals 2 Bft and a short feather 1 Bft)

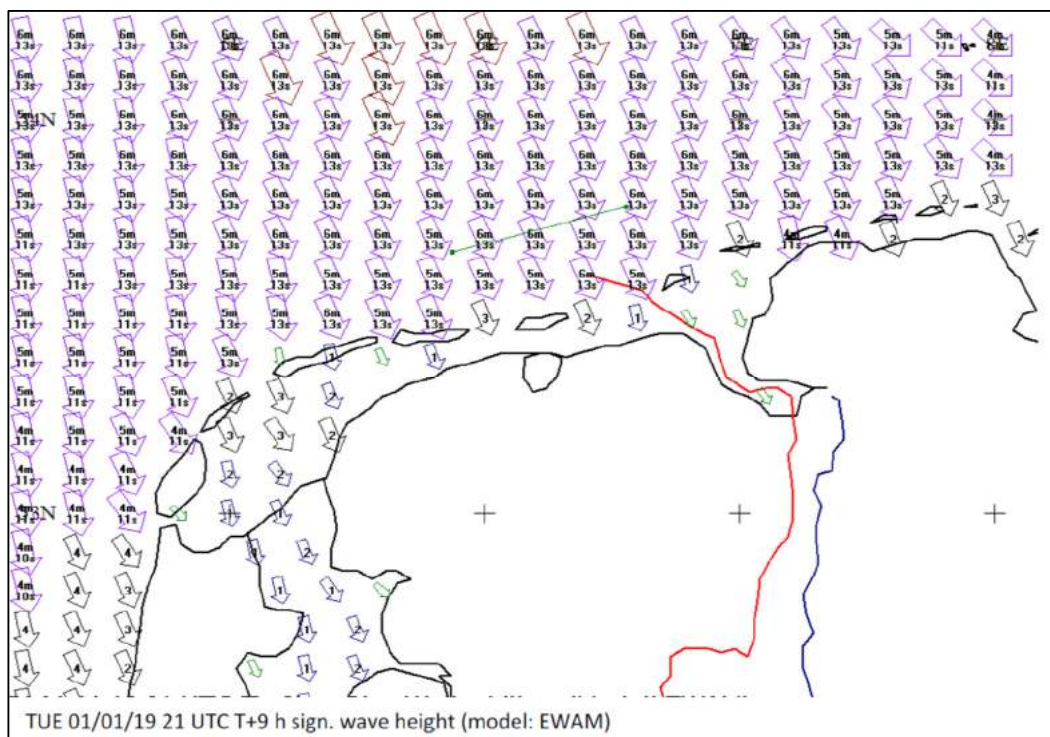
Figure 59: Wave analysis at 21.00 UTC on 1 January 2019 (Source DWD)

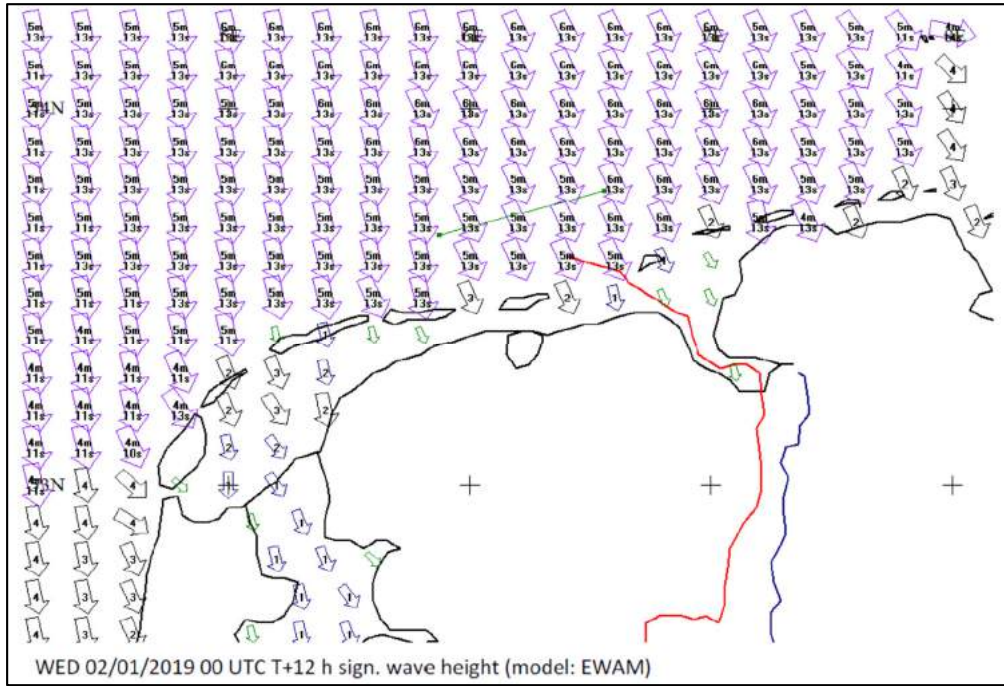
Figure 60: Wave analysis at 00.00 UTC on 1 January 2019 (Source DWD)
